# HOME INSPECTION REPORT

For the property located at  
**1240 Hillcrest Dr., Arroyo Grande, CA**

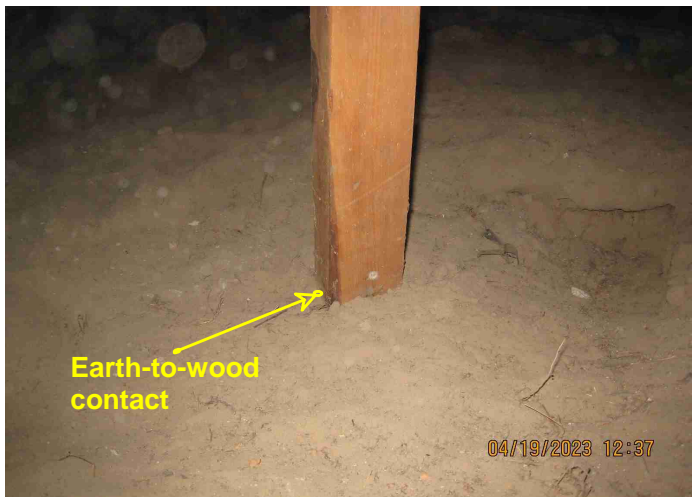
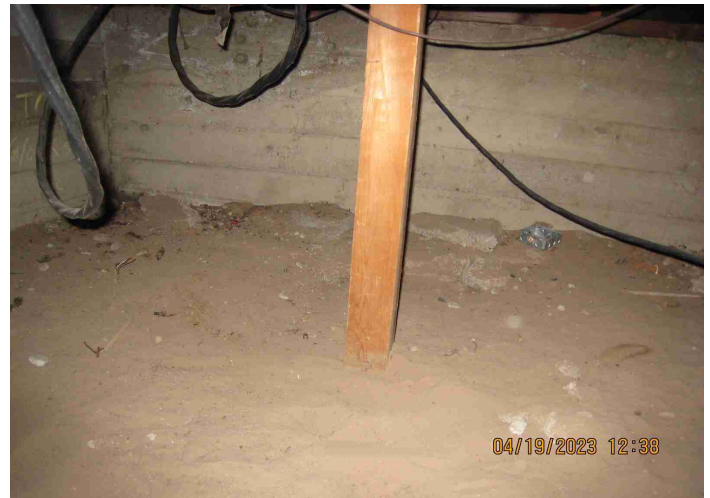
1.6 - Most of the original post supports do not have the recommended 6 inches of clearance from the soil, and some direct earth-to-wood contact was observed. This condition can lead to termite infestation and moisture damage/decay, and correction is recommended as a preventive measure. This condition should also receive mention in the pest control inspection report.

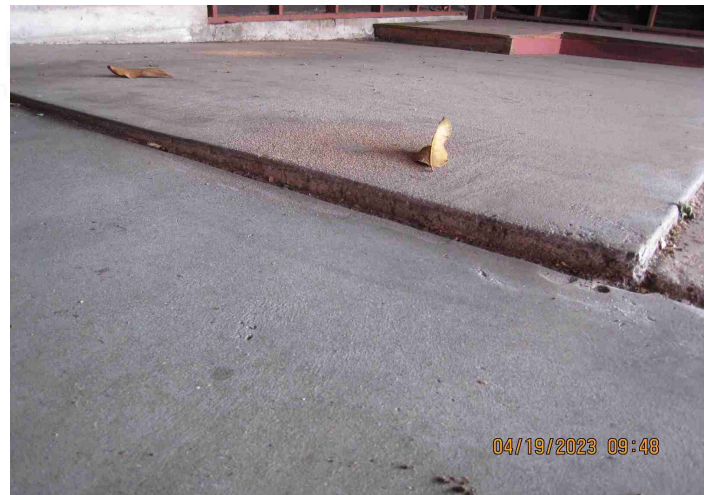
1.15 - The garage slab, which is significantly sloped and appears to have been a driveway before the garage was built on top of it, is cracked and settled and is load bearing. In addition, it is highly unlikely that perimeter footings were installed to accommodate the load of the garage structure when it was built, or that it was done with a building permit and jurisdictional approval. Differential offsets and trip hazards exist. We recommend that you have a licensed structural and/or geo-technical engineer evaluate the garage structure and its foundation system in its entirety at this time and provide you with a qualified specialist opinion on how best to proceed with correcting this condition.

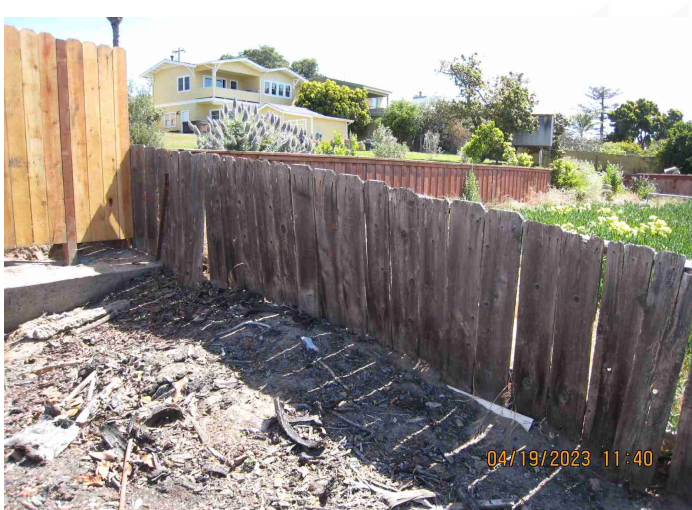
2.3 - Sections of the fence are leaning or damaged and you may wish to have these areas repaired or replaced.

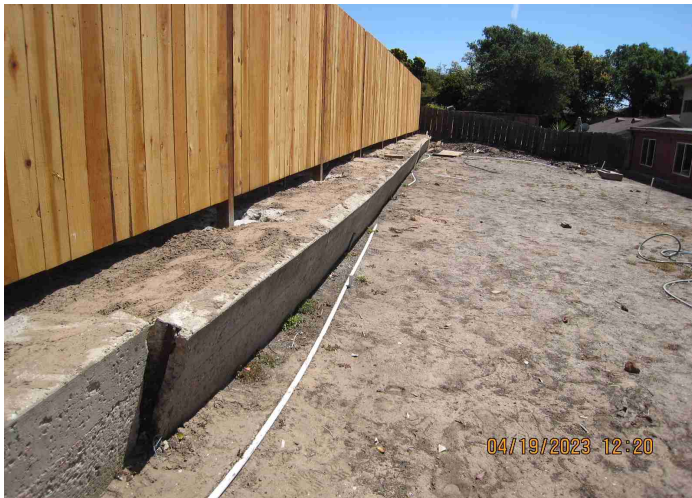
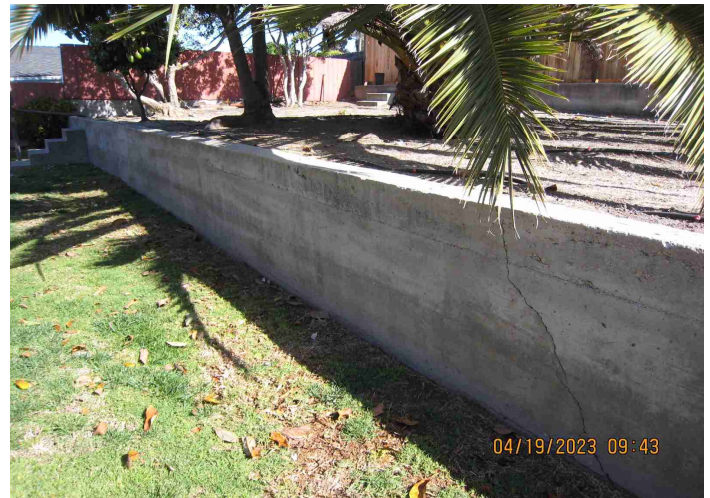
2.4 - The concrete retaining walls (multiple) at the north side of the property have cracked and failed and are leaning heavily. Replacement is needed at this time. The failure of these walls may be due to site instability and you may therefore wish to have this possibility investigated further by an appropriate specialist at this time.

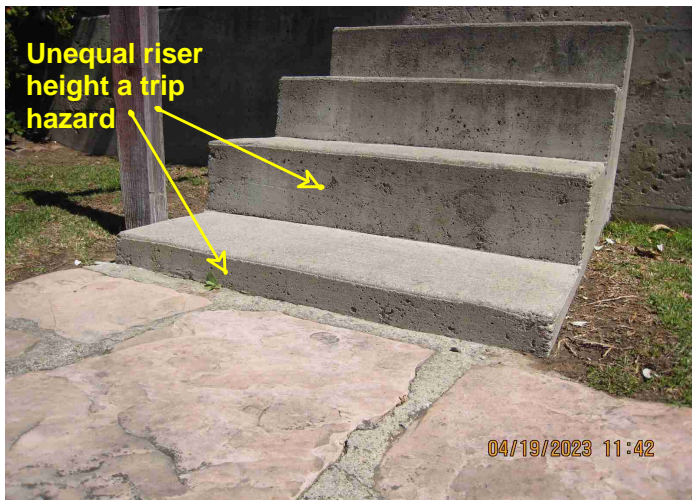
2.8 - The steps at the N/W corner of the property have unequal treads or risers. Steps are required to be uniform to prevent trip-hazards. The rise of any step should be no less than four inches and no greater than seven inches, and the run should be no less than eleven inches. Also, the dimensions of the largest step should not exceed that of the smallest by more than three-eighths of an inch.

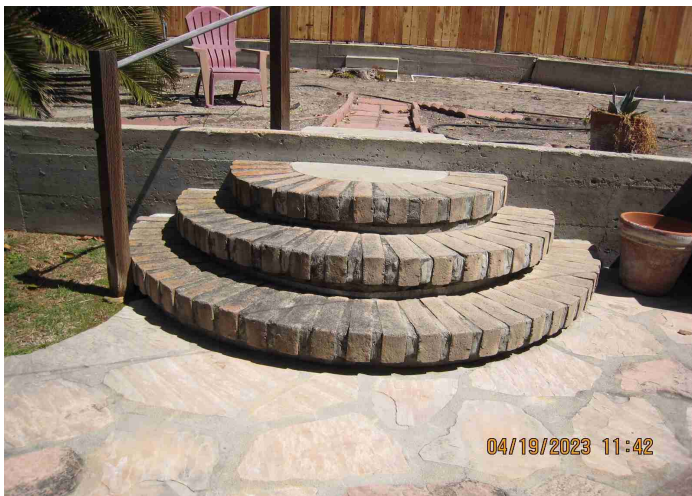
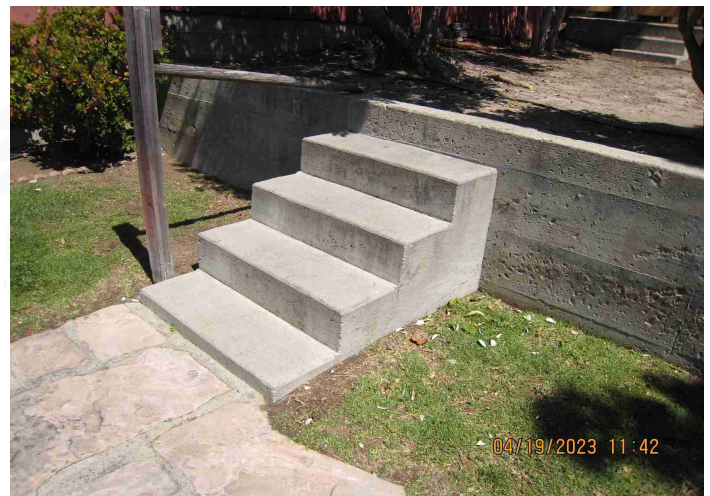
2.9 - Whether or not it was required at the time the home was built, we recommend installing graspable handrails on the stairs at the north side of the property. Stairs with three or more risers that lack handrails are a known trip/fall hazard.

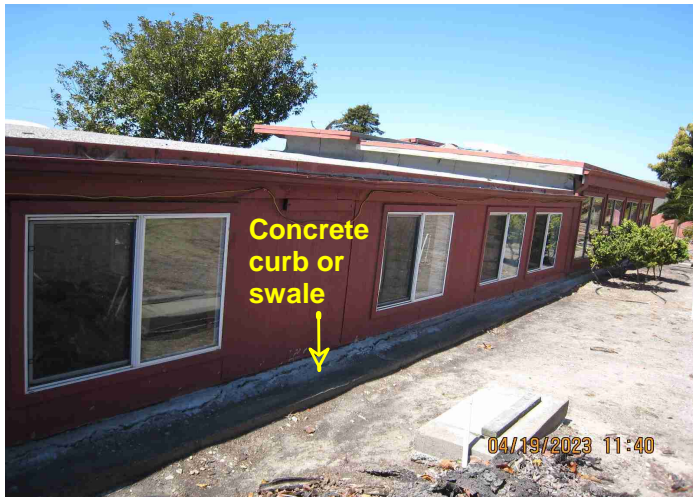
2.15 - A concrete curb or swale has been installed along the base of the wall at the north side of the home. Curbs were once installed as a preventive measure to keep surface water from intruding but are no longer considered an acceptable remedy, and do nothing to address subterranean water. We recommend that you have this condition evaluated by an appropriate grading/drainage specialist for correction at this time. Note: The soil level along the north side of the home is too high and should be lowered and sloped to drain away from the home.

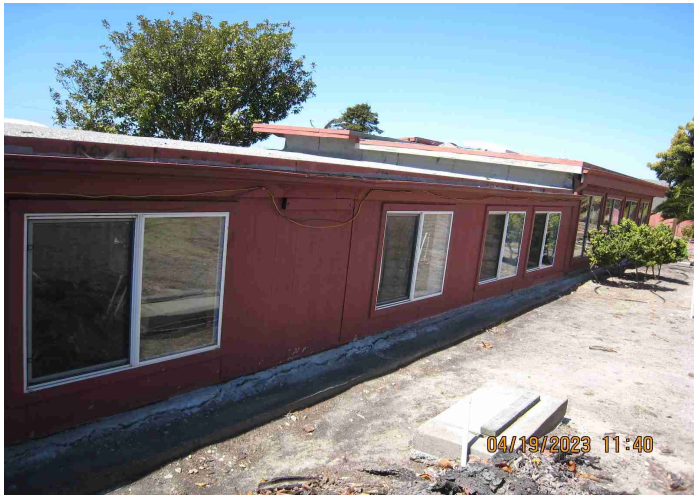
2.16 - The soil or surface grade is not sufficiently graded or sloped to drain runoff water away from the north side of the home. Inadequate drainage and grading can lead to moisture intrusion and create an environment conducive to the growth of mold, fungus and other microorganisms. It can lead to non-uniform structural settlement and damage to the foundation. As a preventative measure we recommend that the soil and hardscaping be sufficiently sloped to drain surface water away from the home for six or more feet, or that an appropriate underground drainage system be installed.

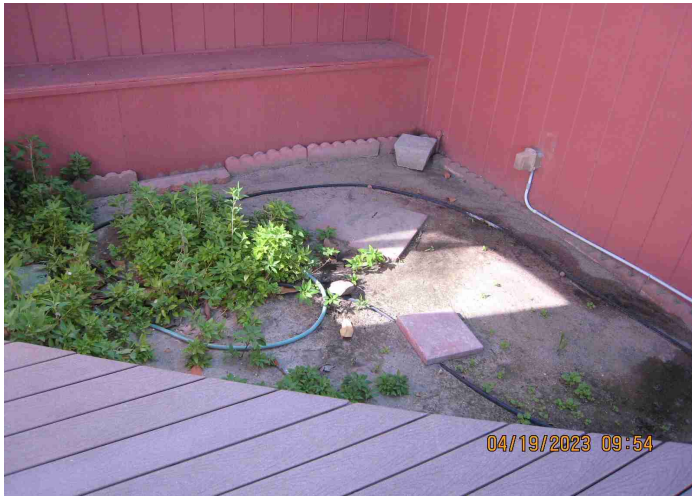
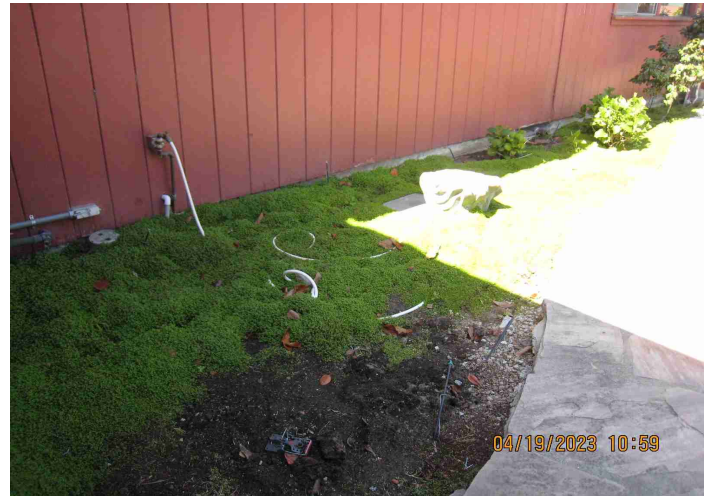
2.17 - There are multiple bordered planter beds around the home that can allow surface water to collect or pool against the base of the home. Wet soil or poor drainage directly adjacent to the home can result in a high moisture level beneath the home, water intrusion, foundation damage/settlement, termite and/or ant infestation and may create an environment conducive to the growth of mold, fungus and other

microorganisms. We recommend that you take preventative measures to help prevent these conditions from occurring.

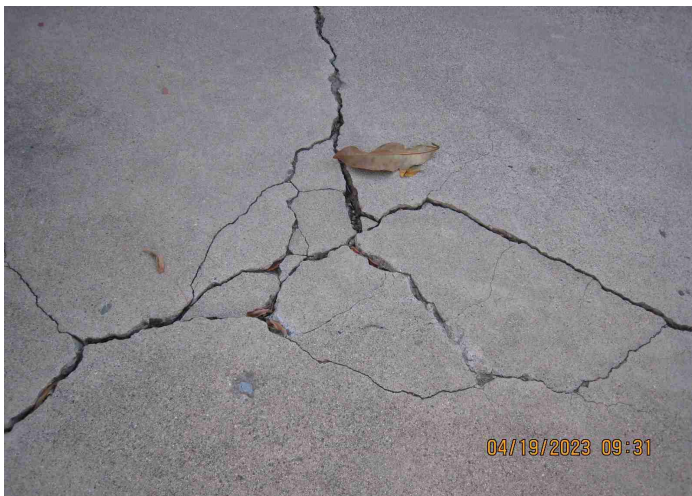
2.19 - Although functional, the concrete driveway is excessively cracked or damaged in areas. Correction/repair is recommended.

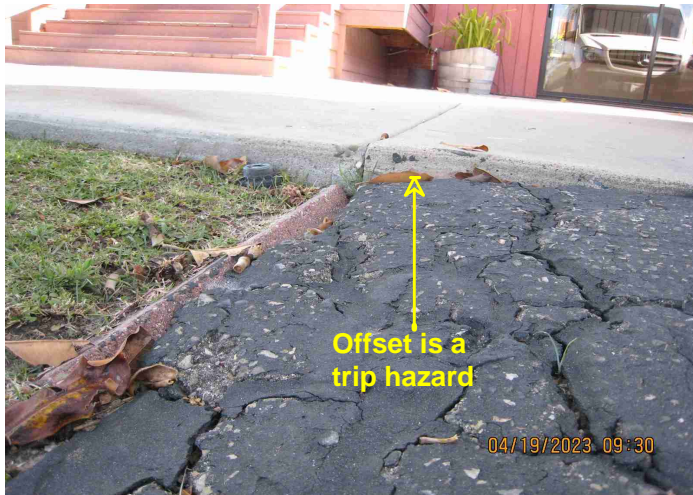
2.20 - There is an offset where the asphalt drive intersects the concrete driveway that is a trip hazard.

Correction/repair is recommended for safety.

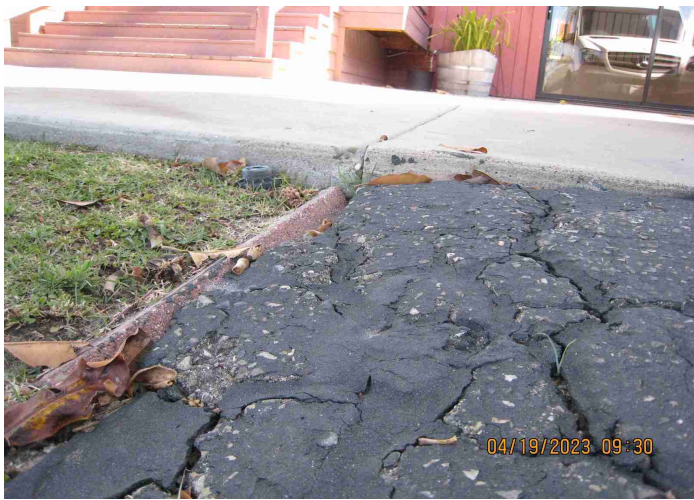
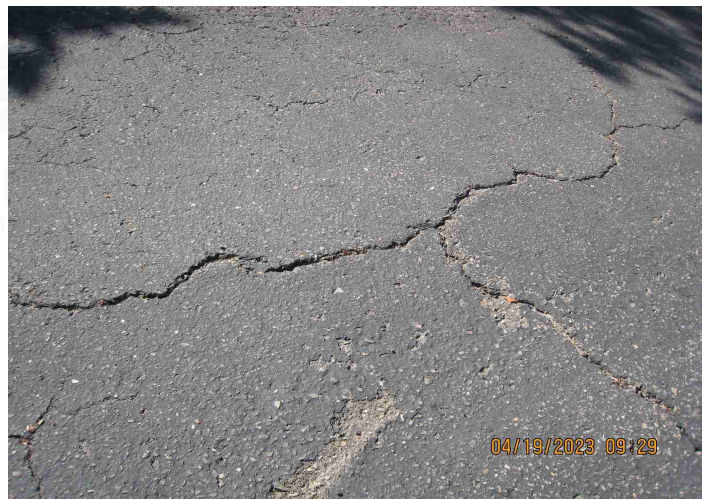
2.21 - Although functional, the asphalt driveways (2) on the property have not been maintained and are significantly cracked/deteriorating. As a preventative measure, we recommend that all cracks be filled/sealed and that the driveways be recoated or resurfaced to extend their lifespan.

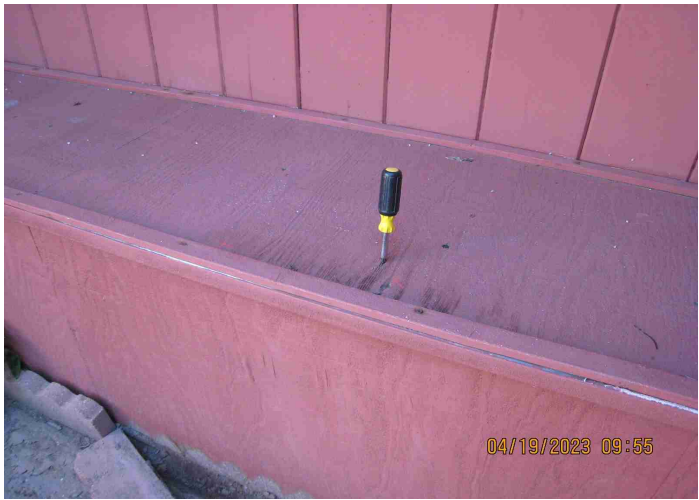
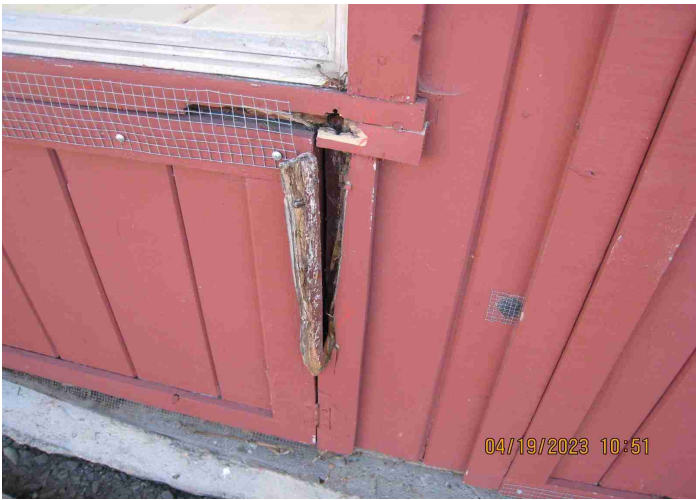
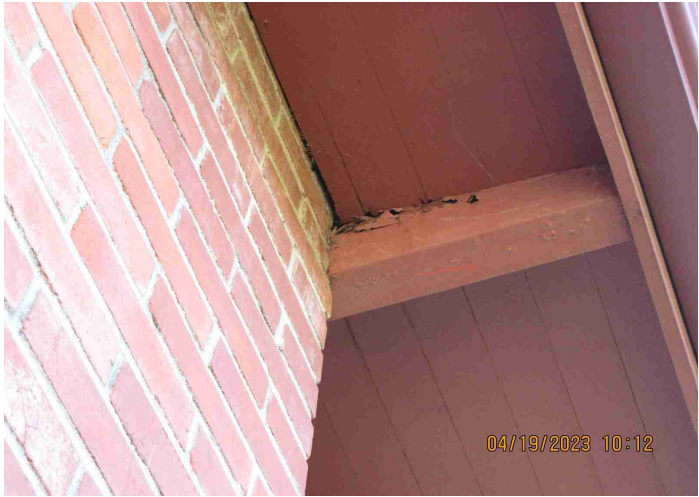
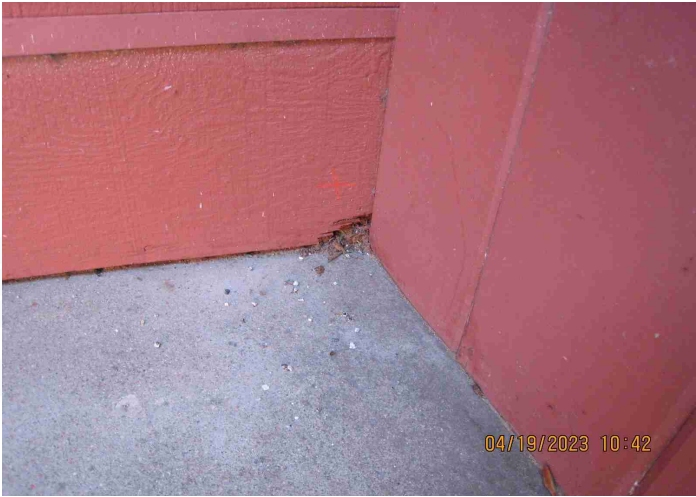
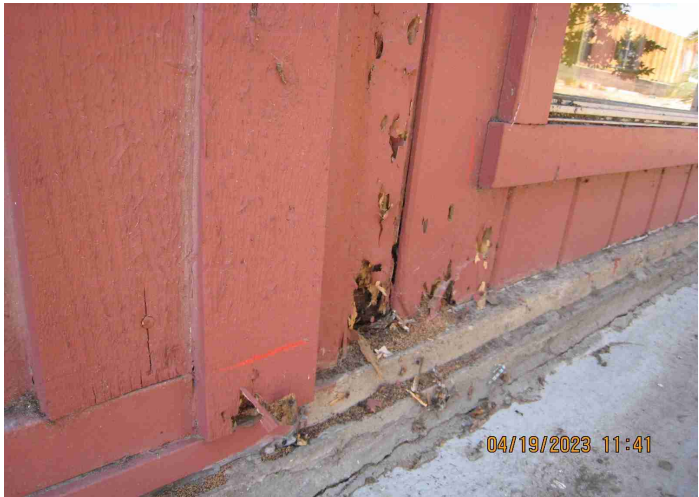
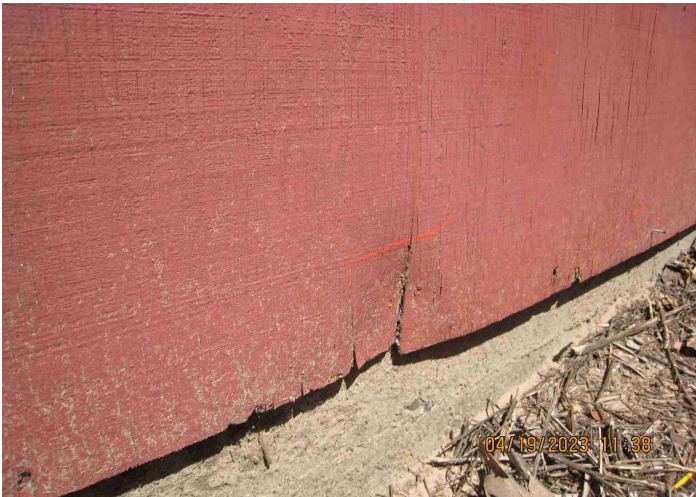
2.22 - A pest control (WDO) inspection and report should confirm the presence of wood damage/decay at a significant number of exterior wood components (siding, fascia, trim, eaves, etc.) and the need and cost for repair/replacement. Your home inspector is neither licensed or qualified to report on the presence of wood destroying insects or organisms (i.e. termites, dry rot, etc.).

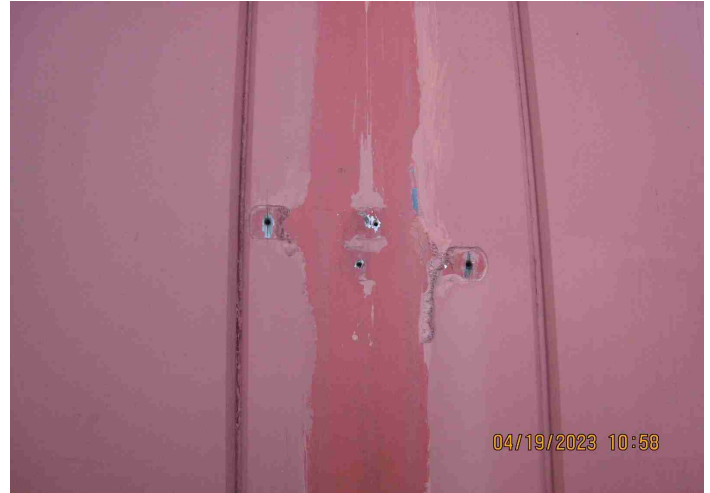
2.24 - There are multiple small holes in the wood siding at various locations that need to be properly repaired or sealed to help prevent against moisture or pest intrusion.

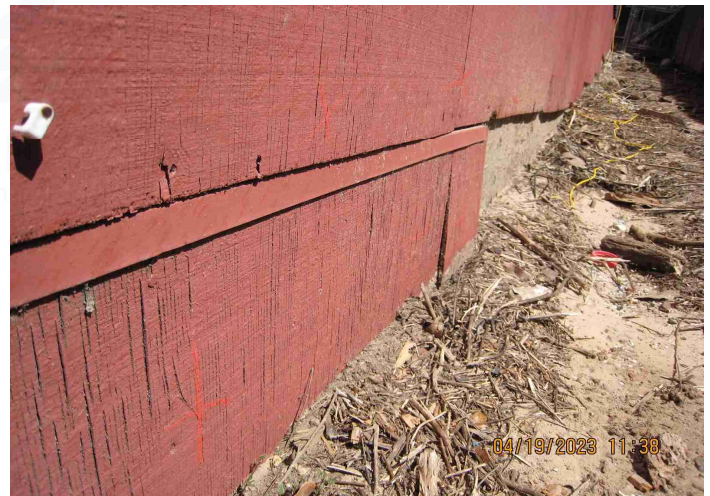
2.25 - A minimum 6 inches of clearance from the wood siding to the soil is needed in a number of areas/locations to help prevent moisture or termite damage.

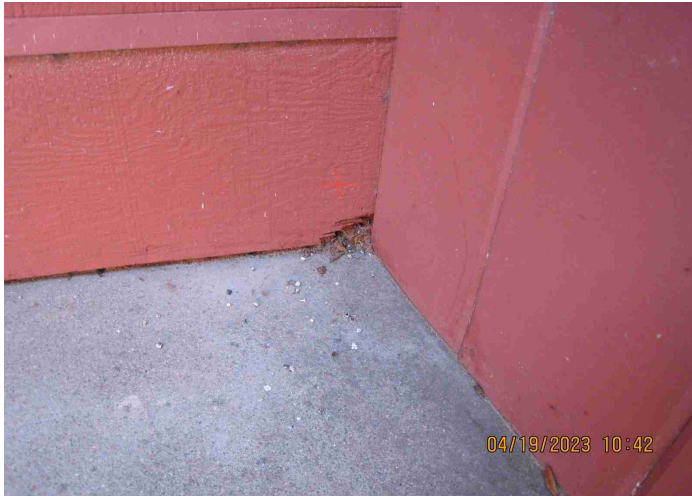
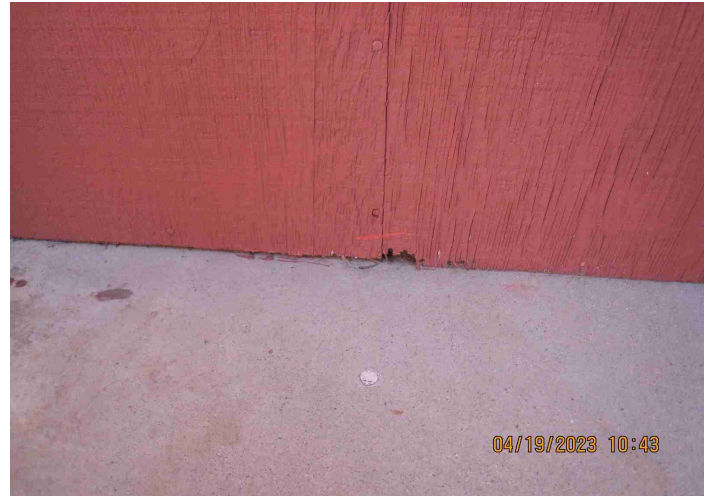
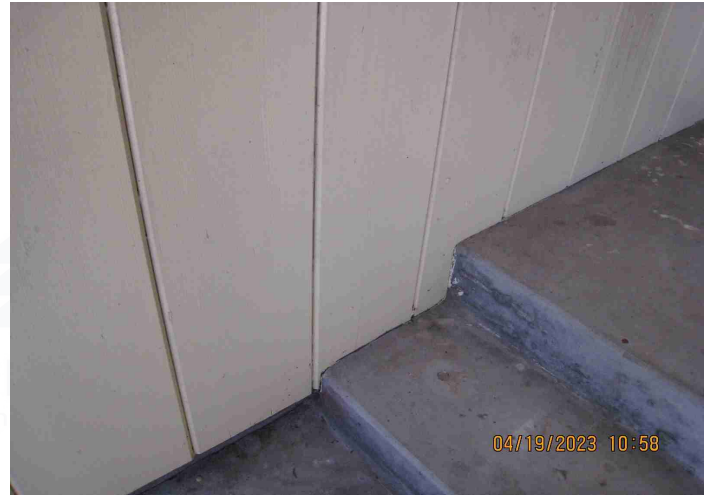
2.26 - There is wood siding in direct contact with the concrete hardscaping in some areas. Providing a min. 1 inch clearance is recommended, as this will help prevent the moisture in the concrete from being drawn up into the wood and subjecting it to moisture damage/decay.

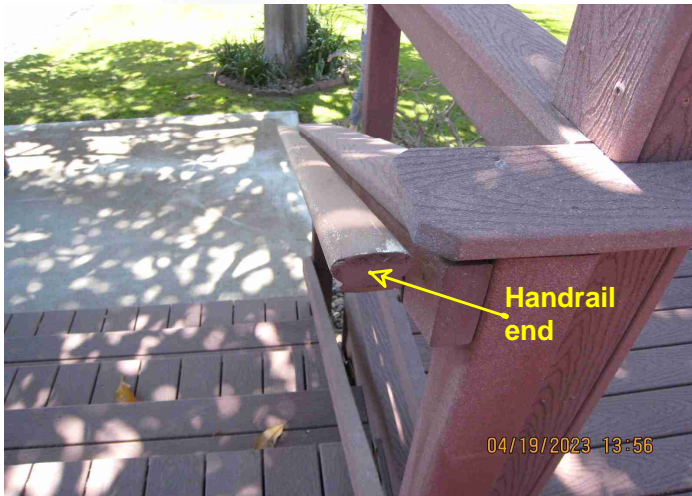
2.37 - Although it may not have been required at the time the handrail was installed, we recommend that you have the ends of the main entry stair handrailing turned into the wall to help prevent snagging of clothing (a potential fall hazard).

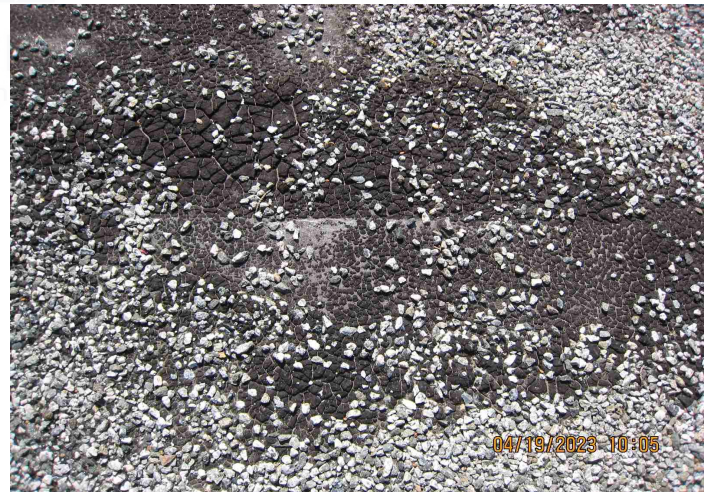
3.2 - The roof is an obsolete gravel type with an initial service life of 20 to 25 years. There are numerous bare spots that need to be covered and some obvious decomposition of the exposed mineral cap sheet. However, because the roof has well exceeded its initial design/service life and we have no knowledge of its service history or the number of roof layers that exist, we recommend that you have a core sample taken by an appropriate specialist at this time. This is important, as a core sample will reveal whether or not the roof has ever been replaced and can simply be serviced again, or if it beyond servicing due to an excessive number of roof layers and will need to be replaced completely. In any event, the roof will need to be evaluated further at this time by an appropriate specialist for further remarks and recommendations.

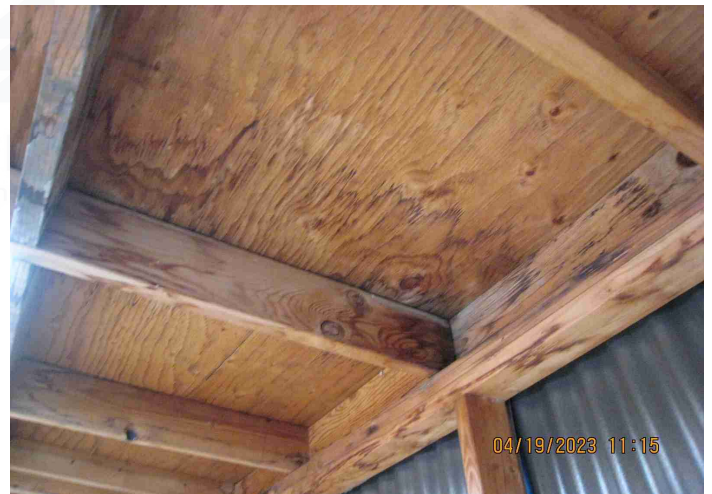
3.3 - There are moisture stains on the ceilings throughout the garage and east workshop areas that imply that the gravel roof has leaked at some point in the past and may still be leaking. However, an active leakage condition can be very difficult to confirm, even when it is raining, and you may wish to have the roof evaluated by a licensed roofing contractor at this time, as we cannot guarantee that the roof does not leak.

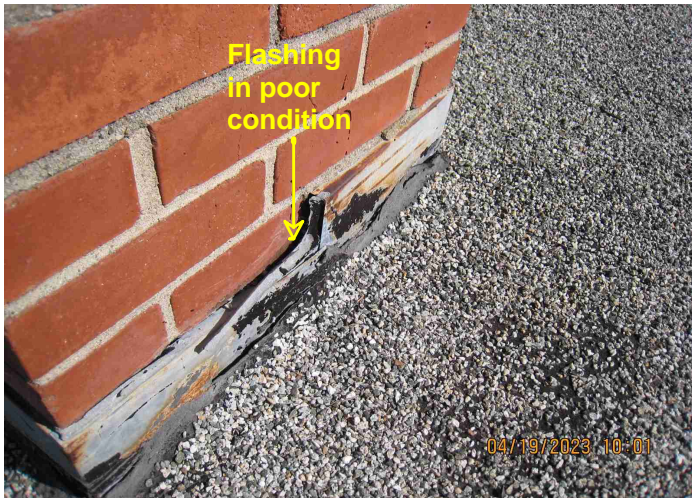
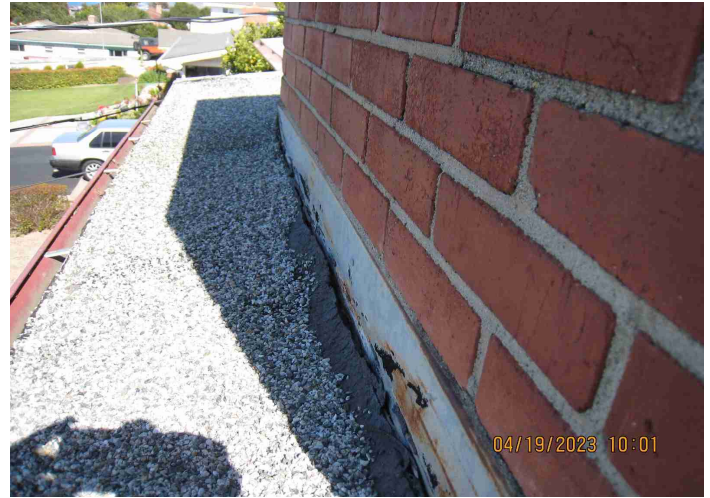
3.4 - The flashing around the base of the chimney is in poor condition and needs repair/replacement to help avoid leakage.

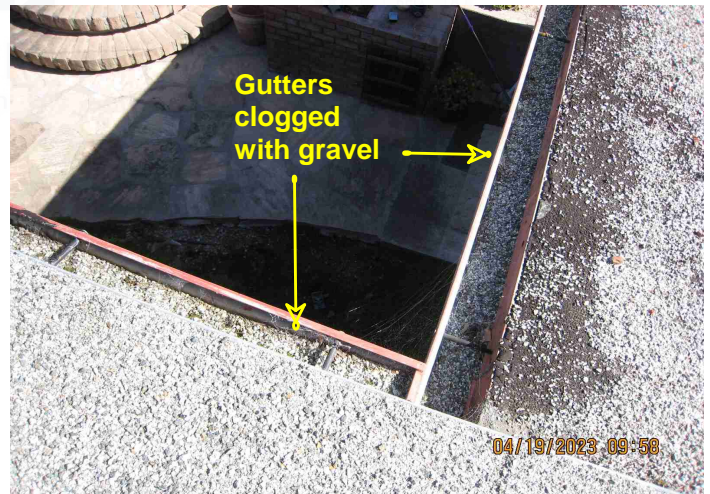
3.7 - The gutters are clogged with gravel and should be cleaned and serviced as needed to drain properly.

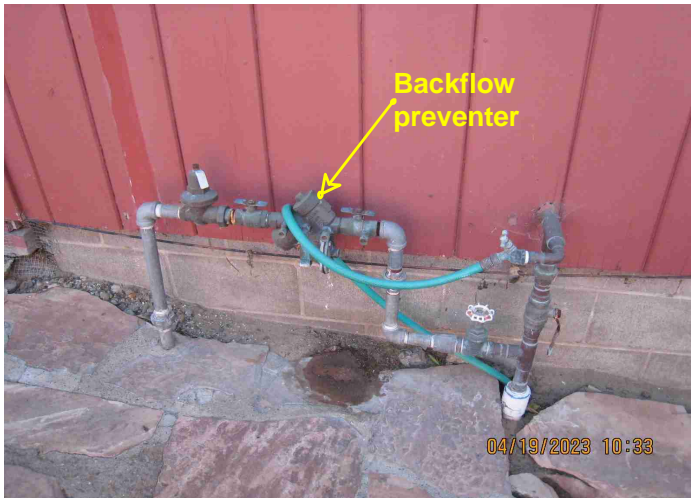
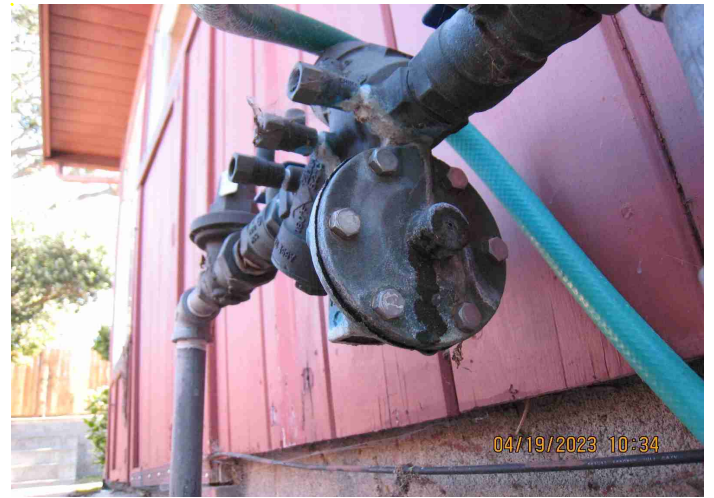
5.6 - The backflow preventer at the west side of the home is leaking and needs repair or replacement.

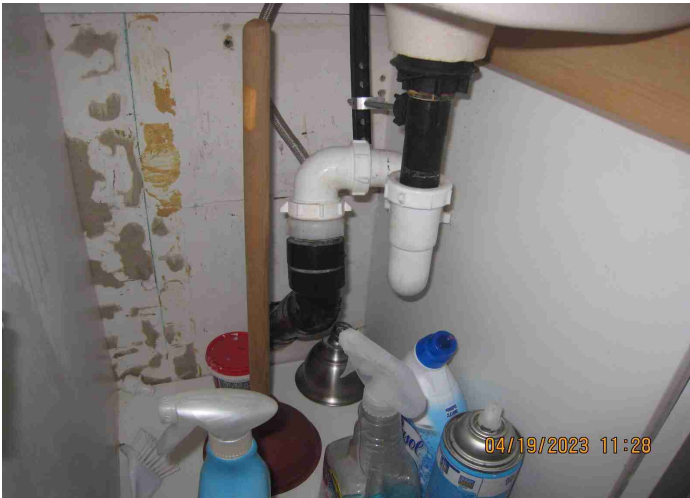
5.10 - The sink drain line in the easternmost bathroom is incorrect because the water seal can be easily siphoned away, which would allow sewer gases to back flow into the residence.

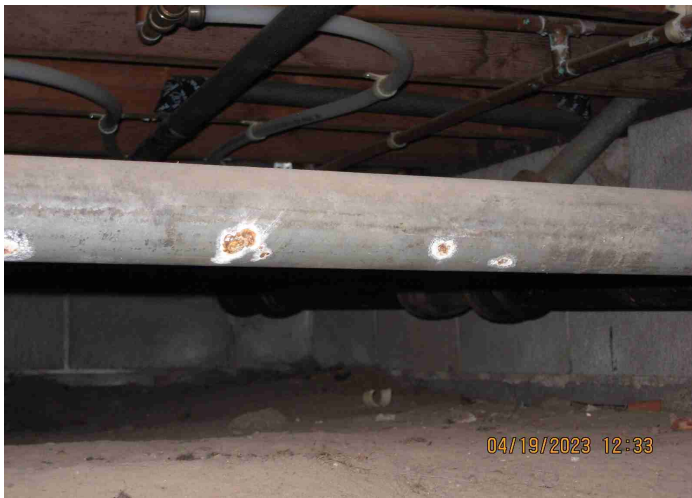
5.25 - There is an older galvanized steel drain line beneath the home that is beginning to rust through (from the inside out) and blister and which should be replaced before it has an opportunity to leak.

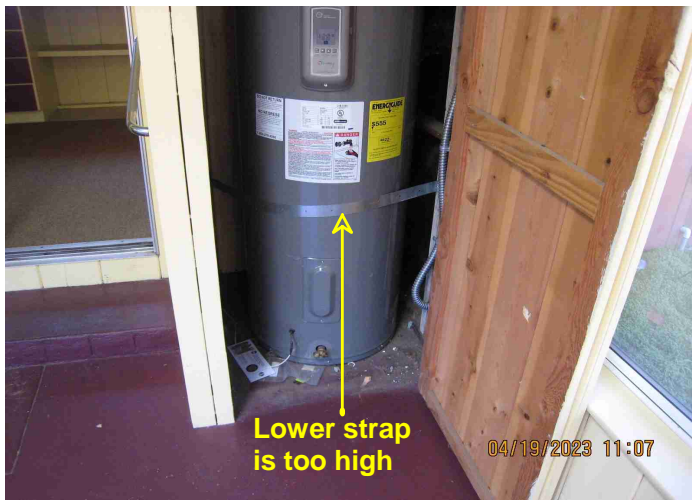
5.38 - The water heater has been strapped and appears adequately braced to resist movement in a seismic event but the lower strap is not within four inches of the top of the controls, thus not placing it in the lower 1/3 of the tank as required. This can be easily remedied by adding a lower third strap or lowering the existing strap.

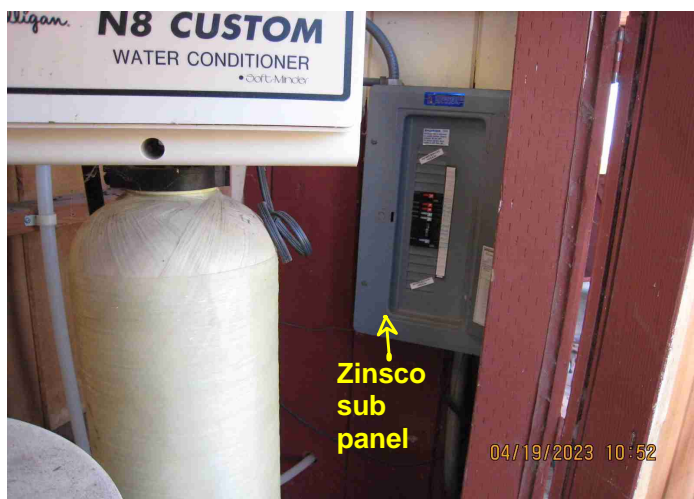
6.10 - The sub panel is manufactured by the Zinsco company. These panels and their circuit breakers have a history of problems including bus bars made from aluminum that oxidize and corrode, breakers that don't trip under normal overload conditions, and breakers that appear to be tripped when they're not. These conditions represent a safety hazard for shock and/or fire. We recommend that an appropriate specialist carefully evaluate the panel and its components and make any necessary corrections/repairs. Once you have taken possession of the property we recommend that you immediately replace the panel altogether with a modern panel that offers more flexibility for new, safer protective technologies like arc fault circuit interrupters (AFCIs).

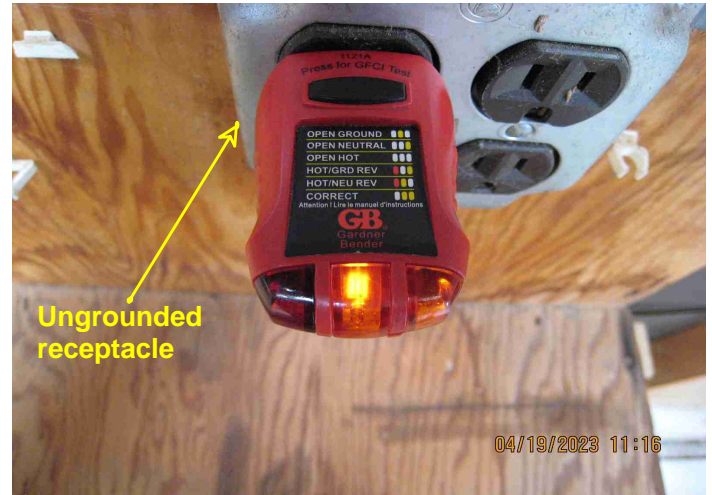
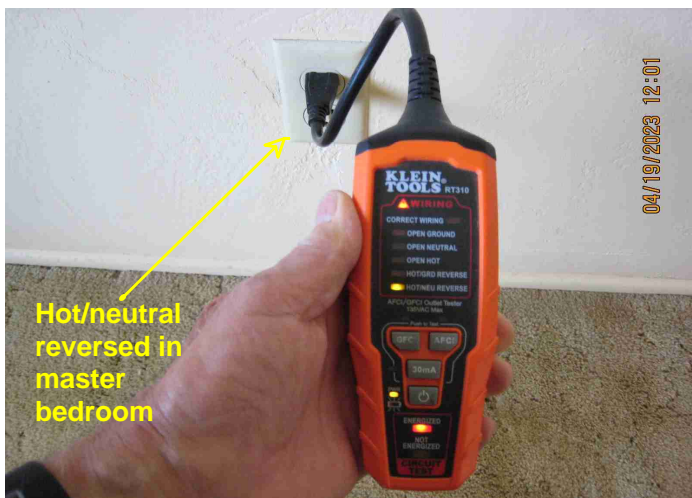
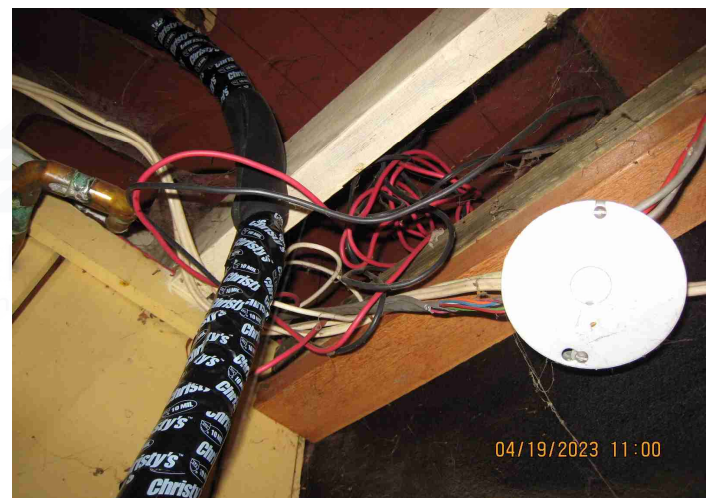
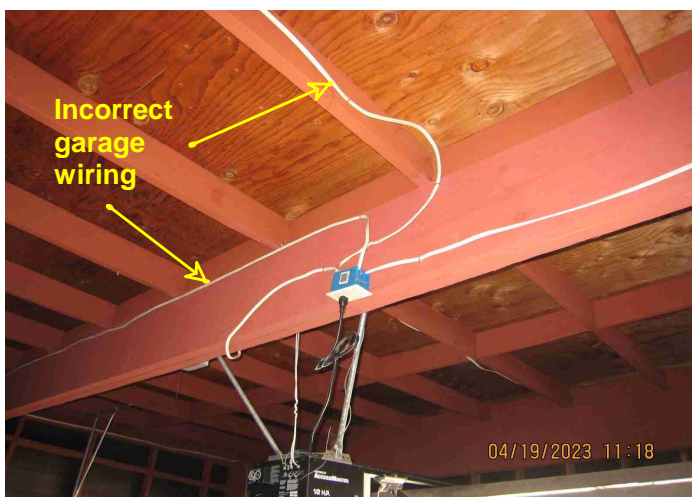
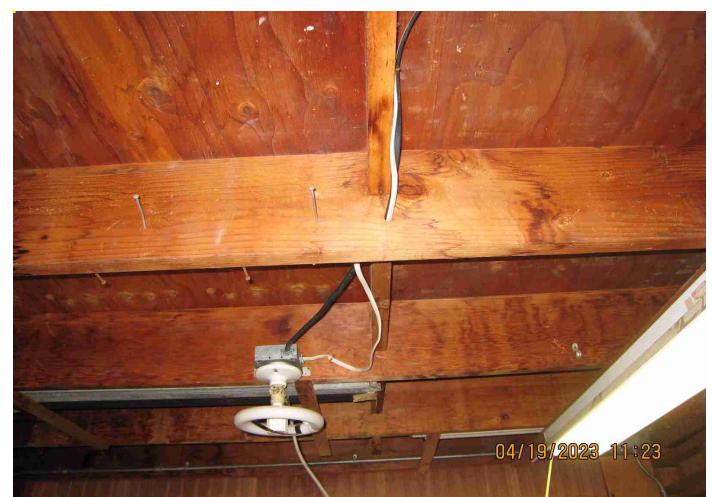
wiring, uncapped and exposed wiring, wiring that does not terminate inside a junction box, ungrounded receptacles, uncovered receptacles, etc. We recommend that an appropriately qualified and licensed electrician go room-to-room to investigate and repair any and all unsafe wiring conditions at this time.

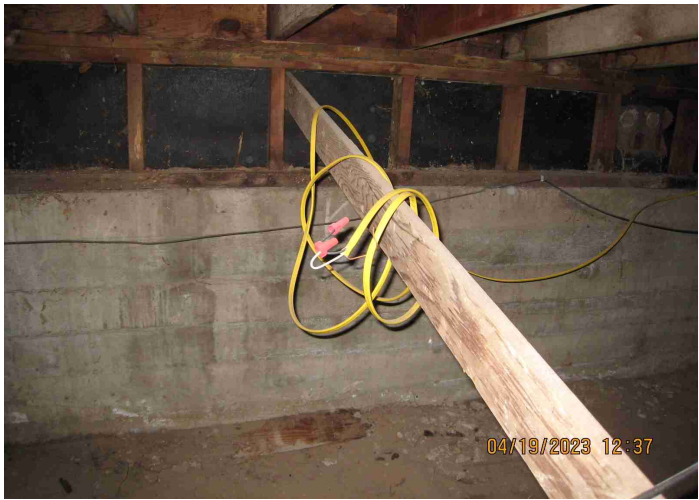
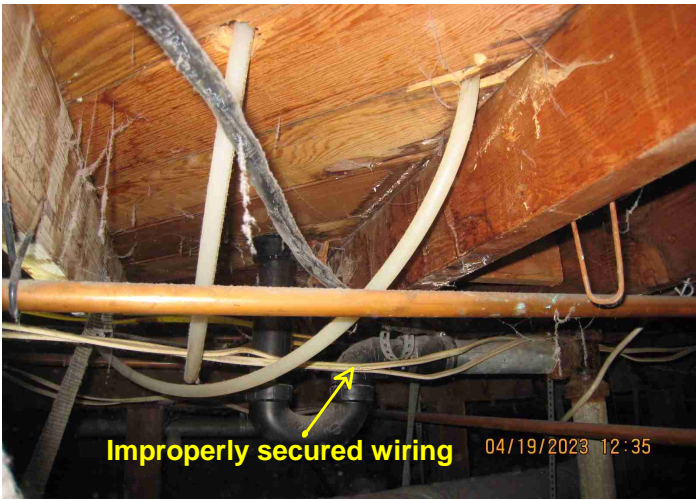
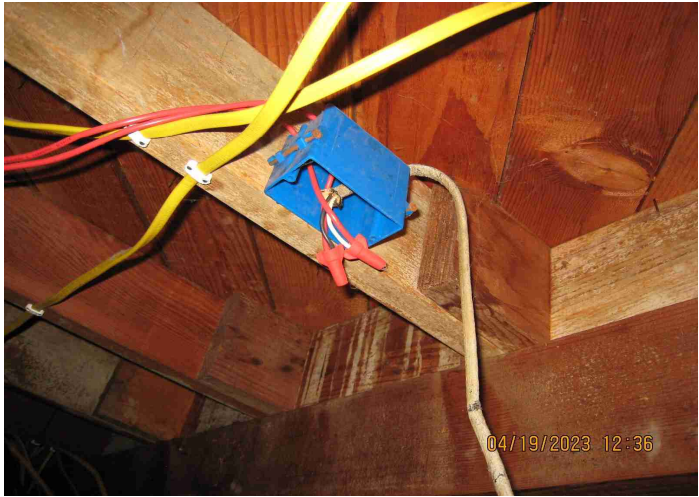
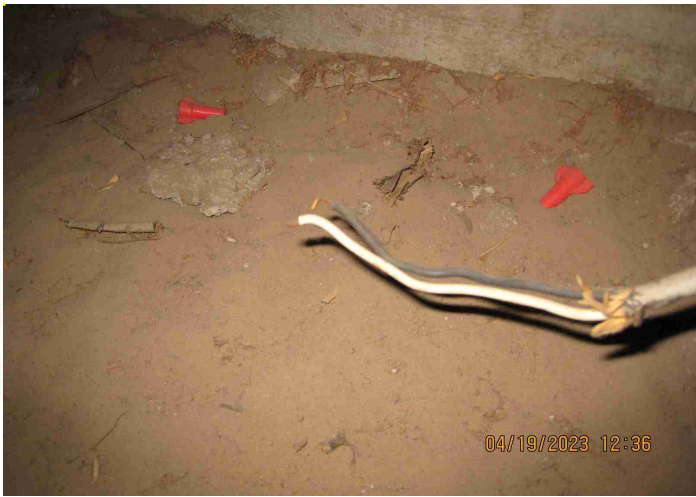
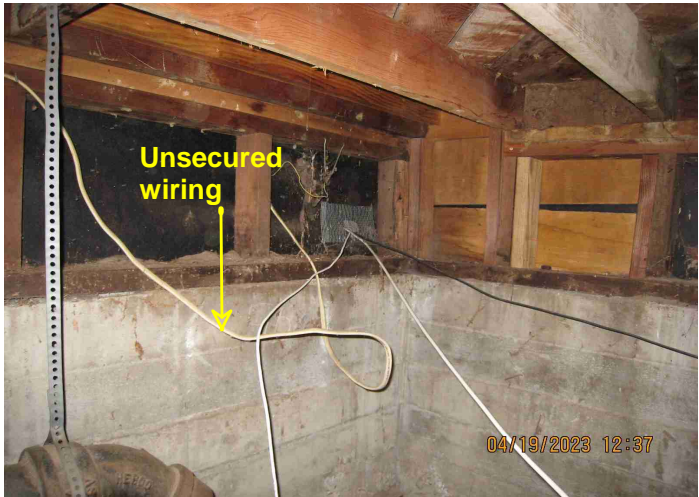
6.23 - There are multiple unsafe or hazardous wiring conditions beneath the home that require repair by a licensed electrician before the electrical system can be considered safe and the home safe for occupancy. These conditions include loose wiring, exposed wiring, uncapped and exposed wiring, wiring that does not terminate inside a junction box, etc. We recommend that an appropriately qualified and licensed electrician enter the crawlspace to investigate and repair any and all unsafe wiring conditions at this time.

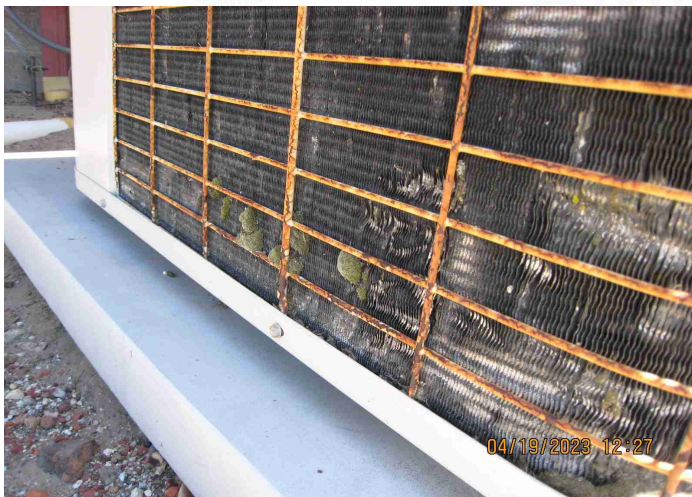
7.8 - There is moss growth and some minor damage to the fins of the condensing coil that may effect the functionality and/or life span of the system, and that you may wish to have corrected/serviced.

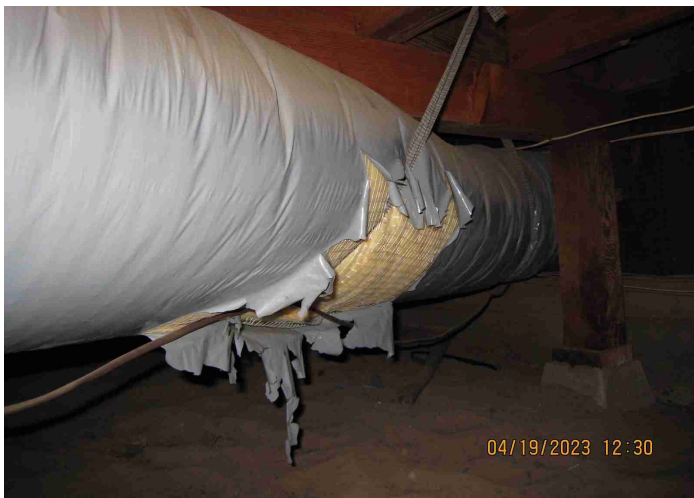
7.13 - The outer sleeve of the visible distribution ducting has been deteriorated by ultra-violet contamination, leading to failure of the ducting. Although this condition will not have any serious immediate consequences other than being energy inefficient, this older, damaged ducting is at the end of its service life and should be replaced.

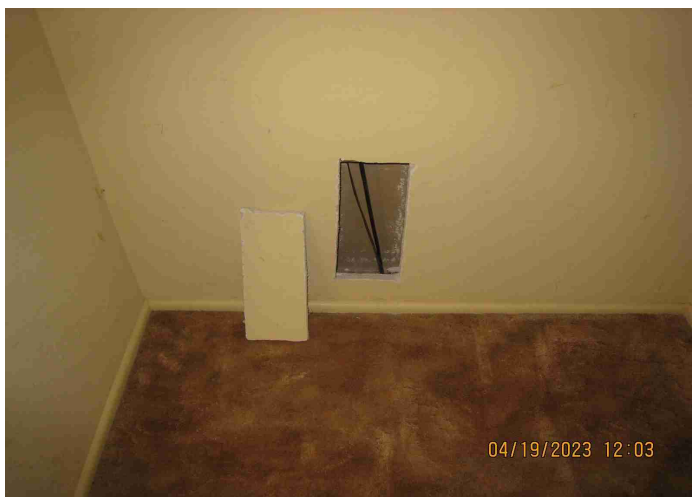
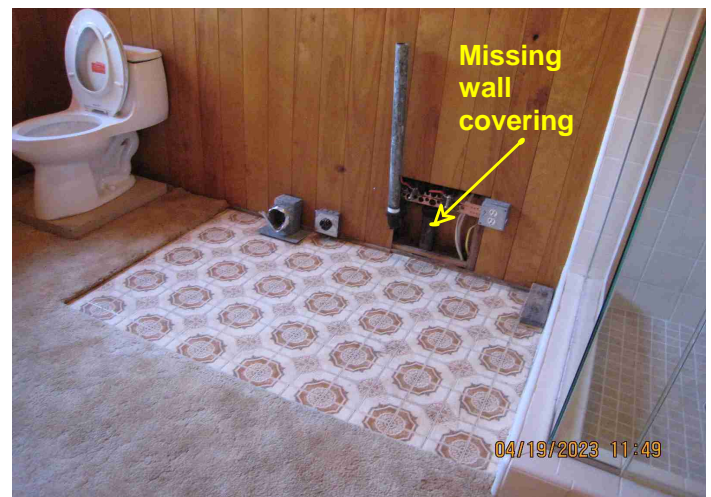
8.5 - There is a missing section of drywall in the master bedroom closet that you may wish to have repaired. Also, there is a section of missing wall covering in the hall bathroom directly behind the laundry area that you may wish to have repaired/ replaced.

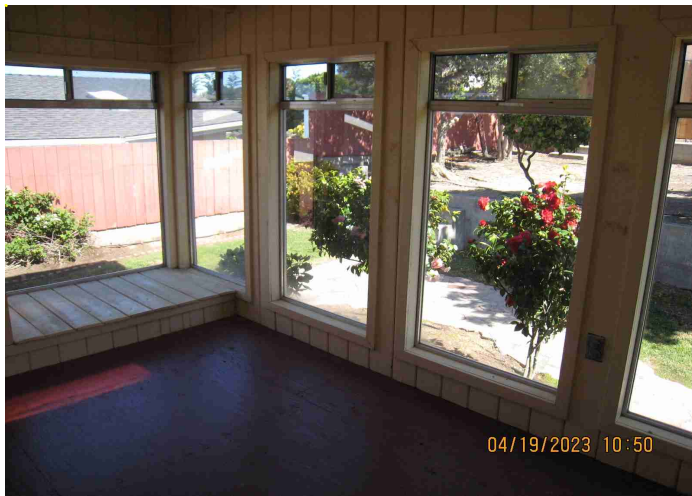
8.8 - The fixed windows in the N/E enclosed patio or sun room are not safety-tempered and are subject to human impact. For safety reasons it is strongly advised that these windows be replaced with ones that include safety-tempered glass.

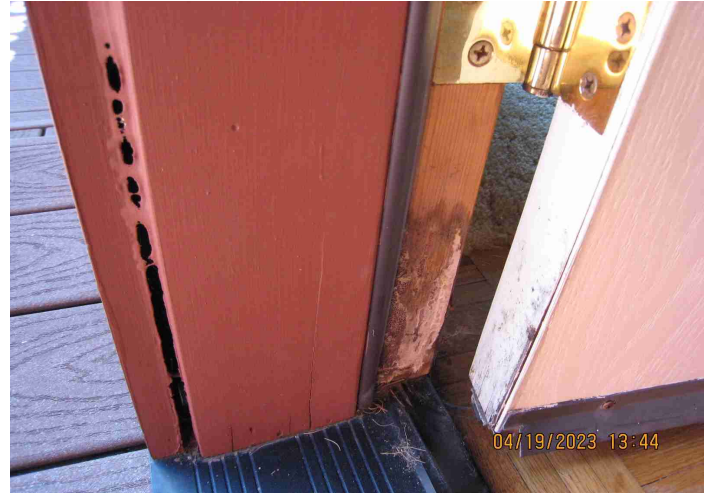
8.10 - There is evidence of water intrusion at the floor at the base of the main entry door. We recommend that the door be evaluated and made watertight by an appropriate specialist. A pest control inspection and report should note the presence of any wood damage or decay and the need, if any, for repair.

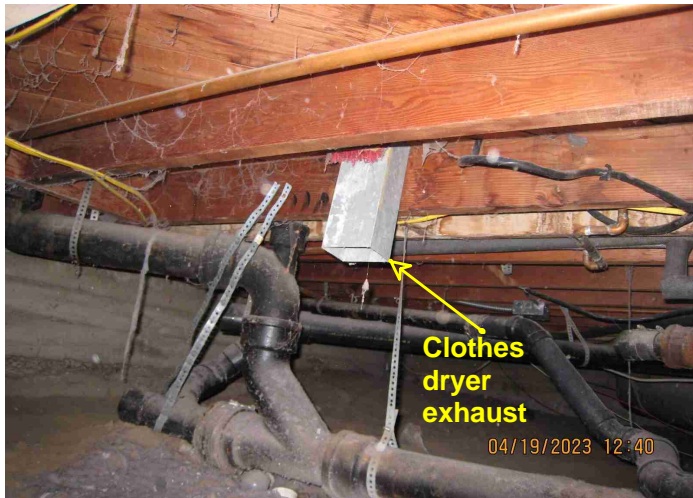
8.22 - The clothes dryer vents incorrectly into the crawlspace beneath the home and should vent to the exterior and be fitted with an approved backdraft damper.
