# HOME INSPECTION REPORT

For the property located at  
**1240 Hillcrest Dr., Arroyo Grande, CA**

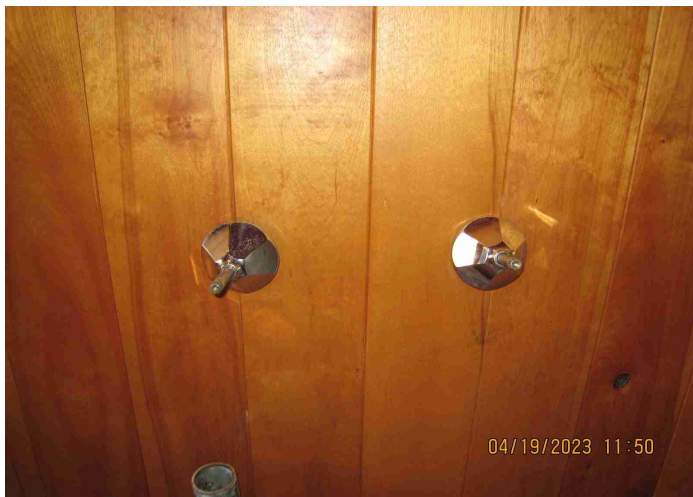
8.23 - There are no shut-off valve handles at the washer supply lines and there should be.

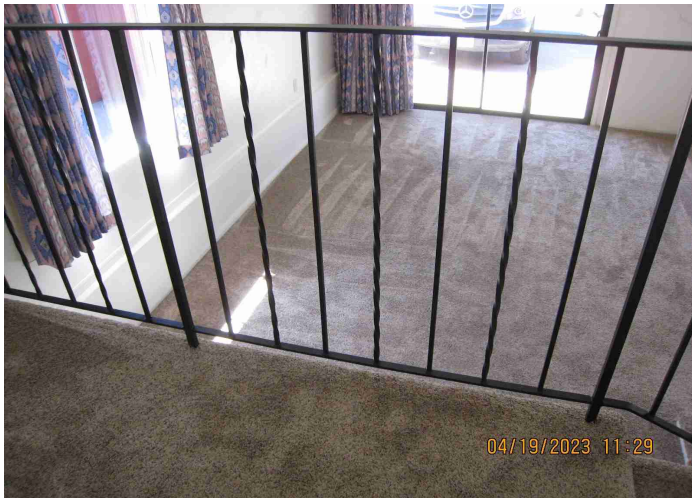
8.33 - The openings in the guard rails/pickets in the converted garage are too wide by current standards, which require that they be no more than four inches apart, and, although not a requirement, we recommend that appropriate precautions be taken to safeguard small children and infants.

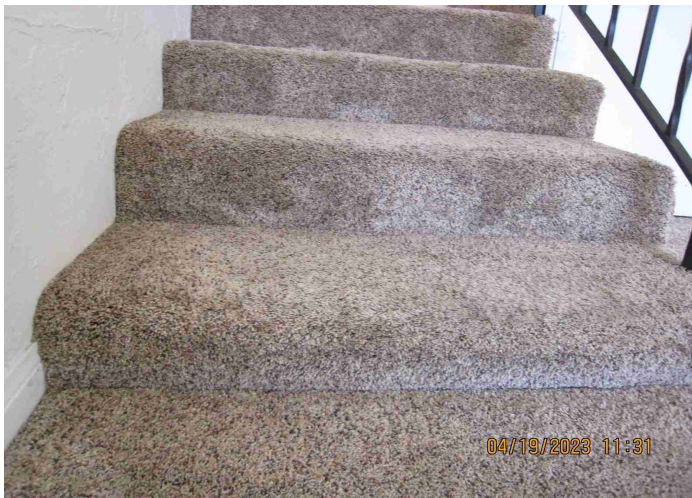
8.34 - The risers at the stairs in the converted garage are not uniform and could therefore prove to be a trip-hazard if not corrected. The rise is that distance between the steps, and the distance in rise between any step should not exceed three-eighths of an inch.

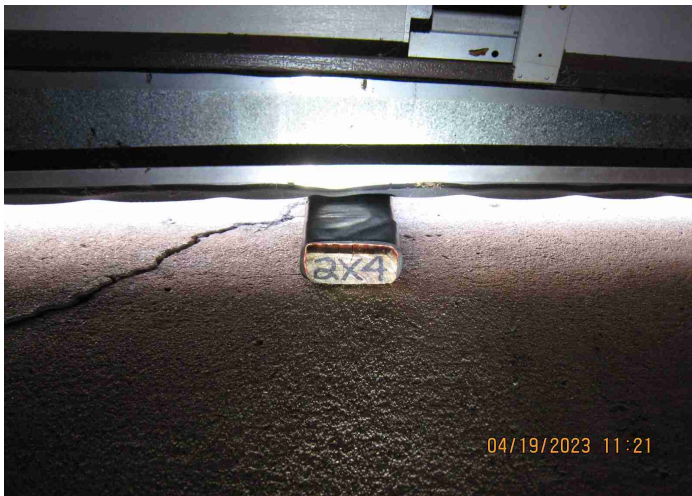
those passing beneath it, and for safety reasons the opener will need to be adjusted or otherwise made to auto-reverse.

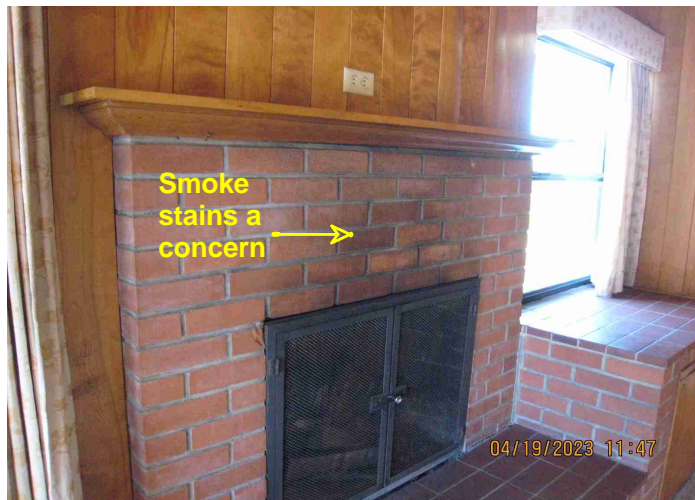
9.2 - This fireplace has a smoking condition as indicated by the smoke patterns located above the fireplace opening. Dangerous gases have been exiting the fireplace into the living area. The exact cause of this condition is unknown but may be due to blockage, an undersized flue, defective construction and/or improper use of the damper. In any event, this condition is considered a potential health hazard and will need to be evaluated by an appropriately qualified fireplace specialist for further remarks and recommendations.

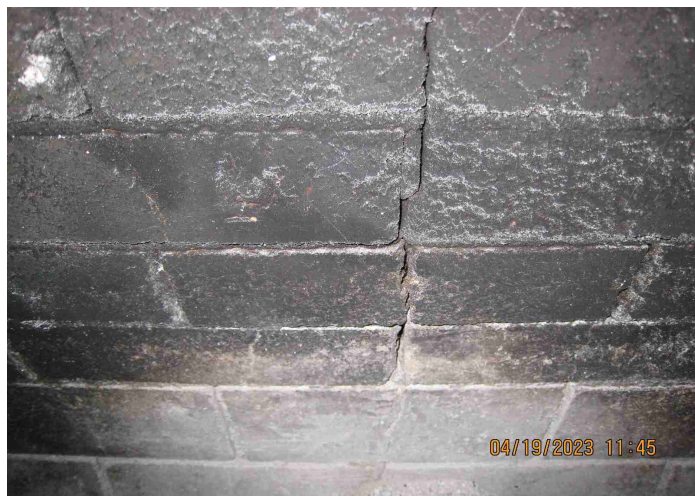
9.3 - There are cracked and deteriorated fire brick in the rear wall of the fireplace that appear to warrant repair at this time.

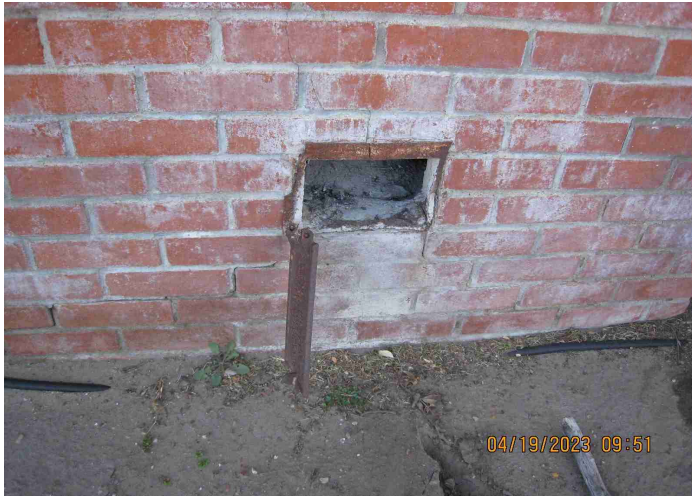
9.5 - The ash dump cover is damaged and needs repair.

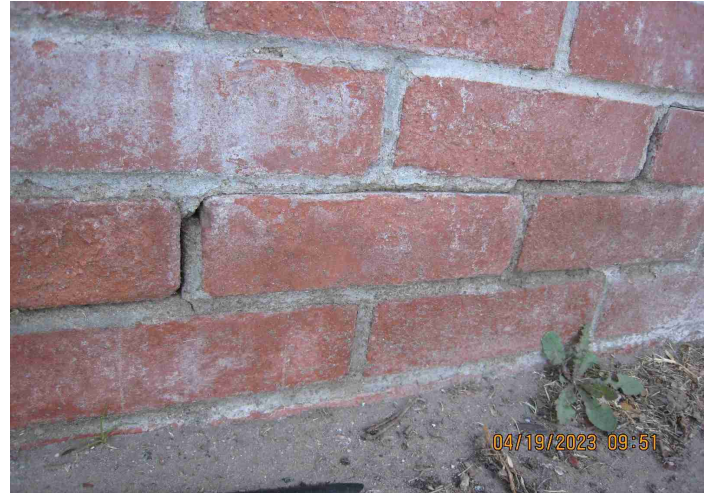
9.11 - The chimney appears to have shifted or settled as evidenced by step cracks in the mortar joints. Repairs are needed. We recommend that the chimney be evaluated by a qualified fireplace specialist for further remarks and recommendations at this time.

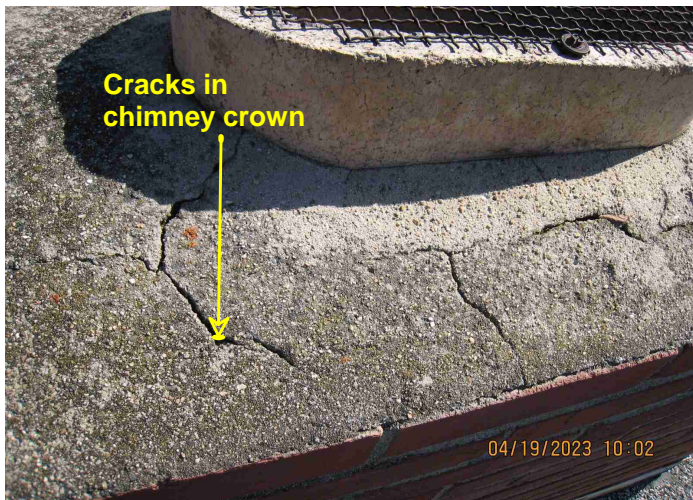
9.14 - The chimney crown, which is designed to seal the chimney wall and shed rainwater, has some cracks/openings that should be sealed/repared to help prevent moisture intrusion.
