# HOME INSPECTION REPORT

For the property located at  
**1240 Hillcrest Dr., Arroyo Grande, CA**

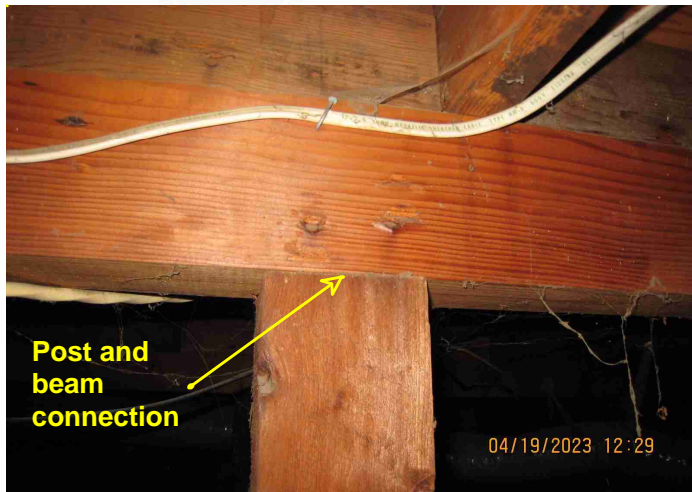
1.5 - Although it may not have been a requirement at the time the home was constructed, consideration should be given to strengthening the nailed post/beam connections with metal ties or straps as a preventative strengthening upgrade.

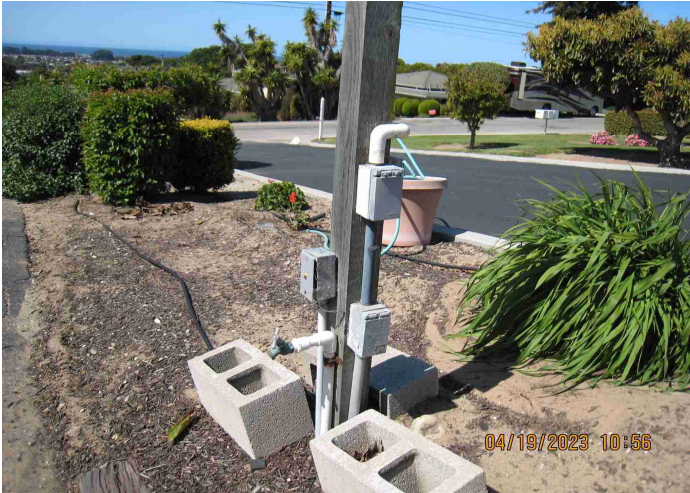
2.12 - There are RV hookups/provisions (plumbing, electrical, etc.) on the property that were not evaluated or tested as a part of our inspection. If this is a concern you may wish to have them evaluated at this time by an appropriate specialist.

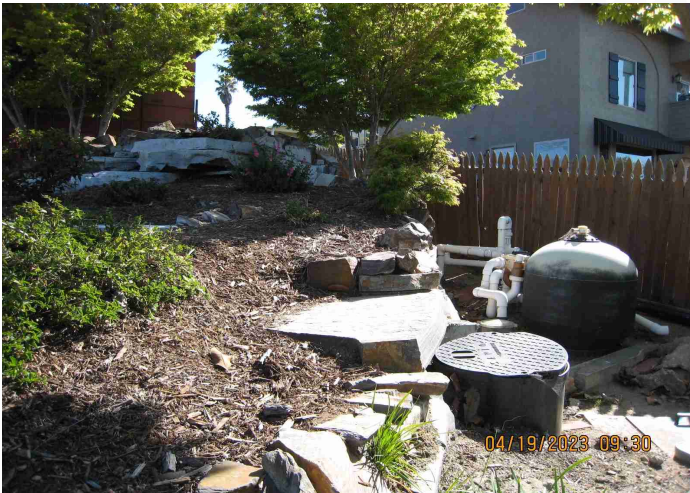
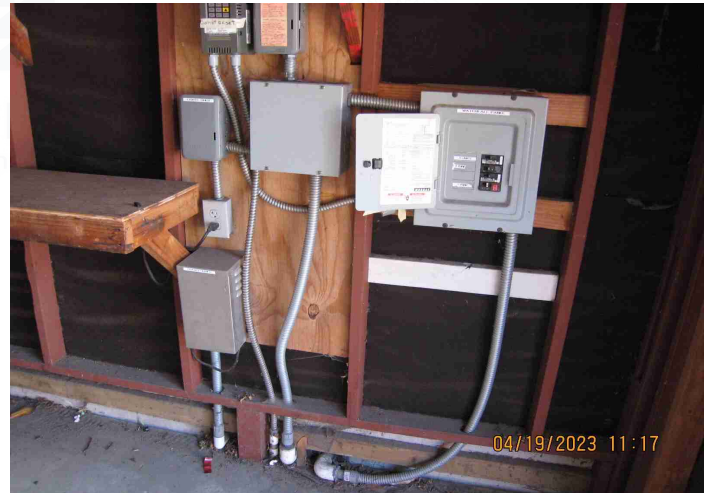
2.13 - The waterfall and related equipment at the east side of the property was not inspected. Also, the electrical provisions for the equipment that are located inside the garage on the south wall, are not energized or operational. Further evaluation by an appropriate specialist is needed in order to determine in any of this equipment is functional or serviceable.

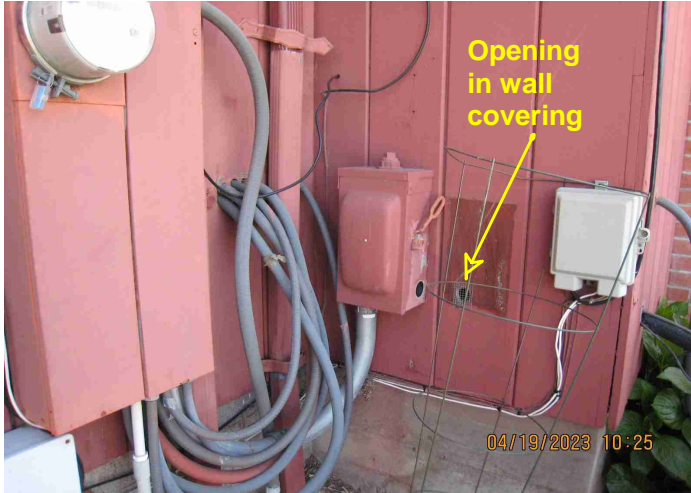
2.24 - There are multiple small holes in the wood siding at various locations that need to be properly repaired or sealed to help prevent against moisture or pest intrusion.

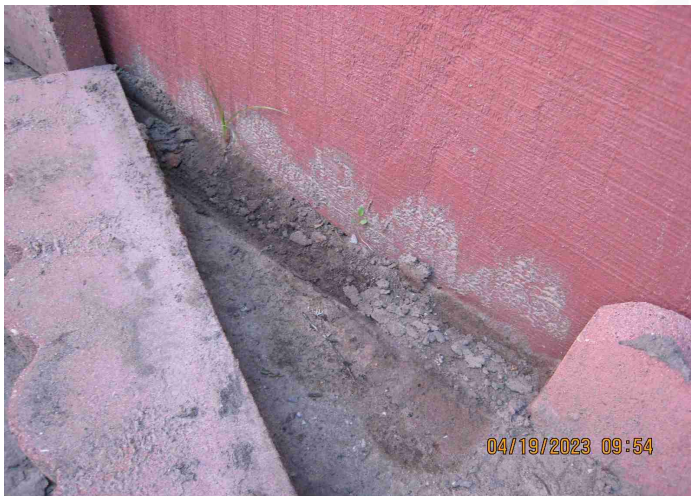
2.25 - A minimum 6 inches of clearance from the wood siding to the soil is needed in a number of areas/locations to help prevent moisture or termite damage.

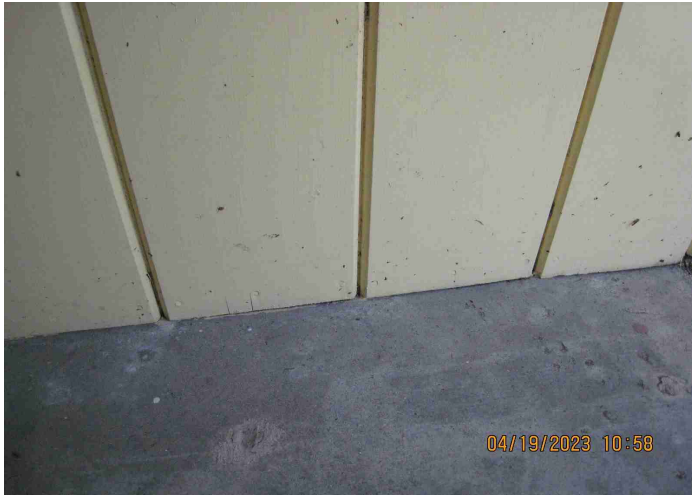
2.26 - There is wood siding in direct contact with the concrete hardscaping in some areas. Providing a min. 1 inch clearance is recommended, as this will help prevent the moisture in the concrete from being drawn up into the wood and subjecting it to moisture damage/decay.

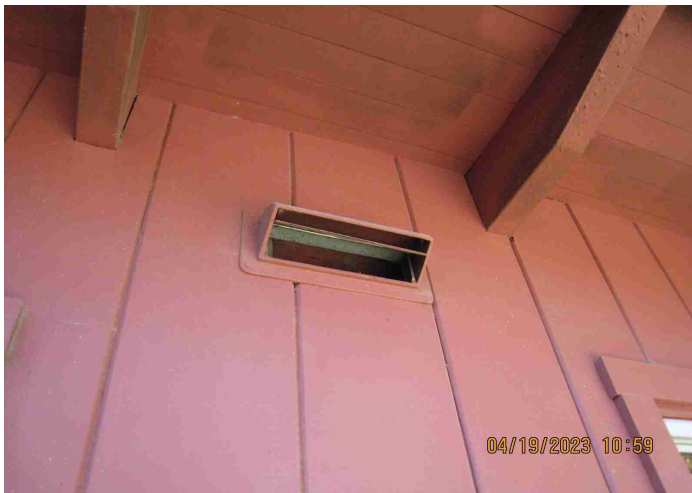
2.27 - Older/original stove exhaust vent cover at the north side of the kitchen needs screening or removal to help prevent pest intrusion. The vent is not in use at this time.

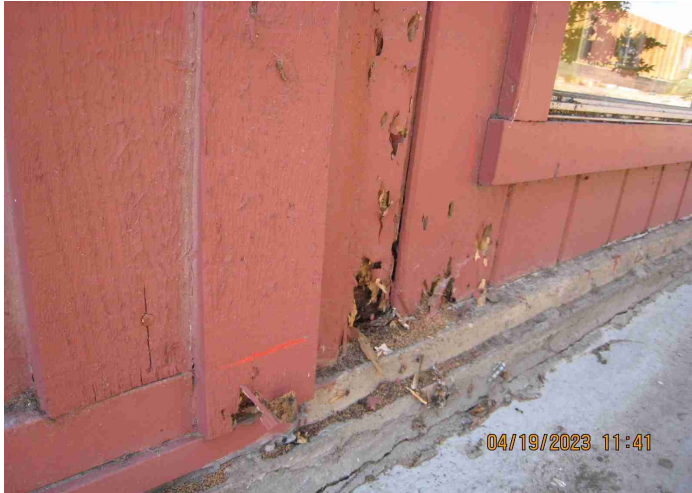
2.28 - A Branch 3 pest control (WDO) inspection and report should confirm considerable damage/decay to the wood siding and the need/cost for repair/replacement.

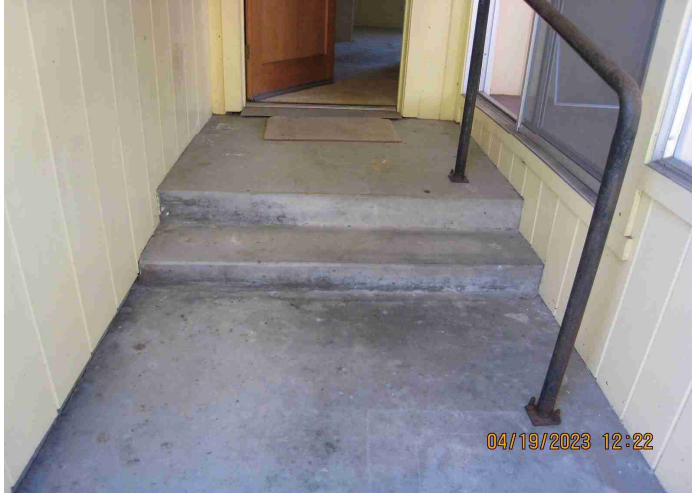
2.36 - The risers at the north concrete entry stairs are not uniform and could therefore prove to be a trip-hazard. The rise is that distance between the steps, and the difference in rise between any step should not exceed three-eighths of an inch.

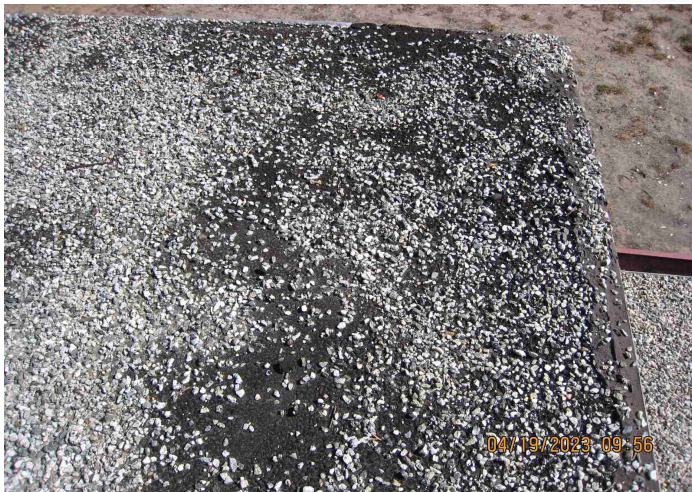
3.2 - The roof is an obsolete gravel type with an initial service life of 20 to 25 years. There are numerous bare spots that need to be covered and some obvious decomposition of the exposed mineral cap sheet. However, because the roof has well exceeded its initial design/service life and we have no knowledge of its service history or the number of roof layers that exist, we recommend that you have a core sample taken by an appropriate specialist at this time. This is important, as a core sample will reveal whether or not the roof has ever been replaced and can simply be serviced again, or if it beyond servicing due to an excessive number of roof layers and will need to be replaced completely. In any event, the roof will need to be evaluated further at this time by an appropriate specialist for further remarks and recommendations.

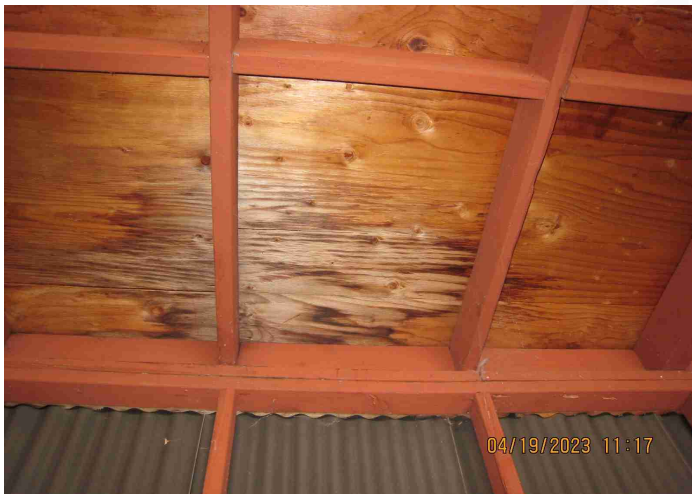
3.3 - There are moisture stains on the ceilings throughout the garage and east workshop areas that imply that the gravel roof has leaked at some point in the past and may still be leaking. However, an active leakage condition can be very difficult to confirm, even when it is raining, and you may wish to have the roof evaluated by a licensed roofing contractor at this time, as we cannot guarantee that the roof does not leak.

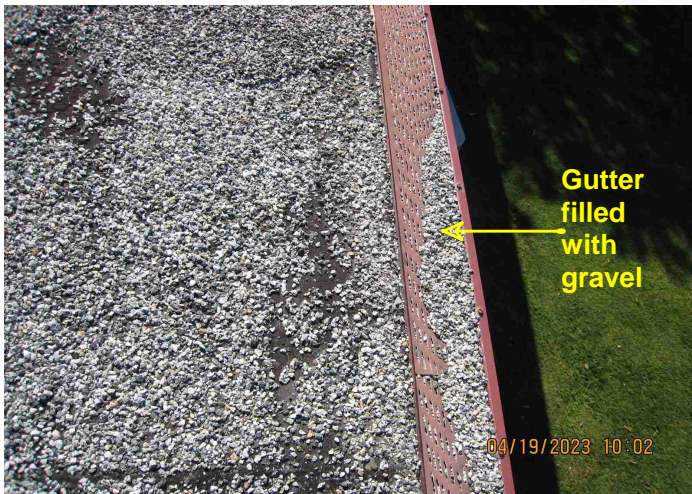
3.7 - The gutters are clogged with gravel and should be cleaned and serviced as needed to drain properly.

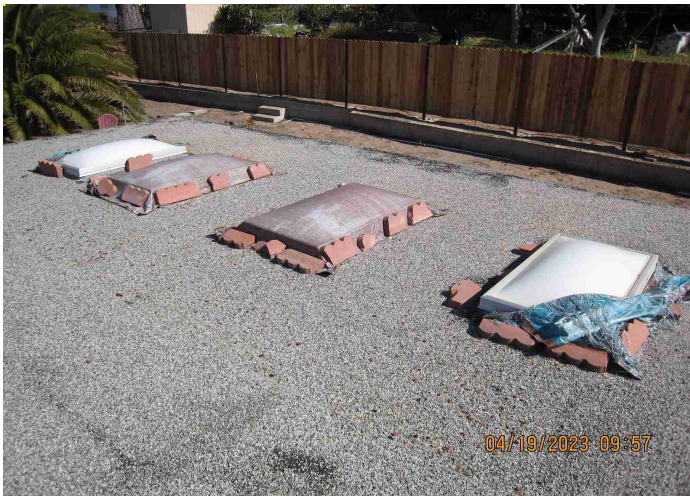
3.10 - Some of the skylights have been covered with tarps and are not visible and should be uncovered and evaluated for defects at this time.

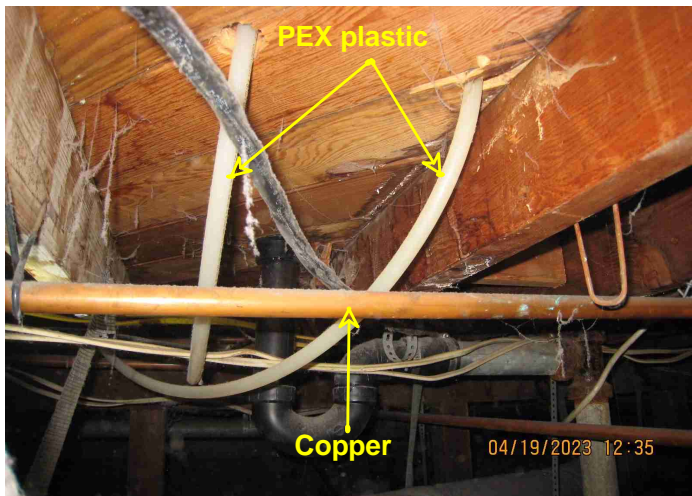
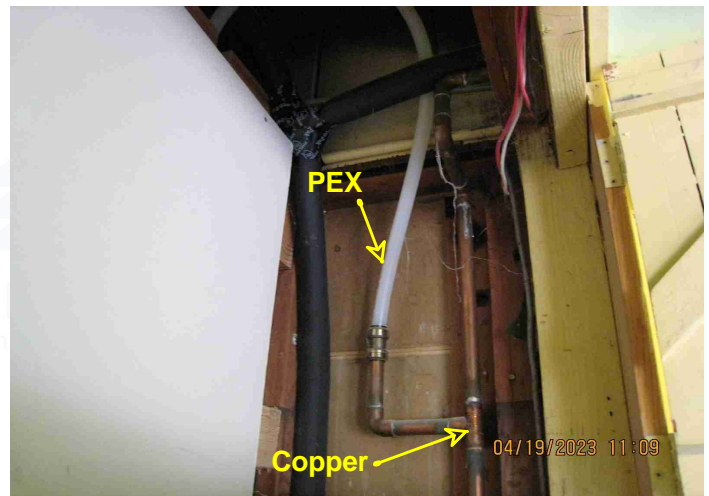
5.5 - Where visible, the water supply piping in the home appears to be a combination of copper and PEX plastic.

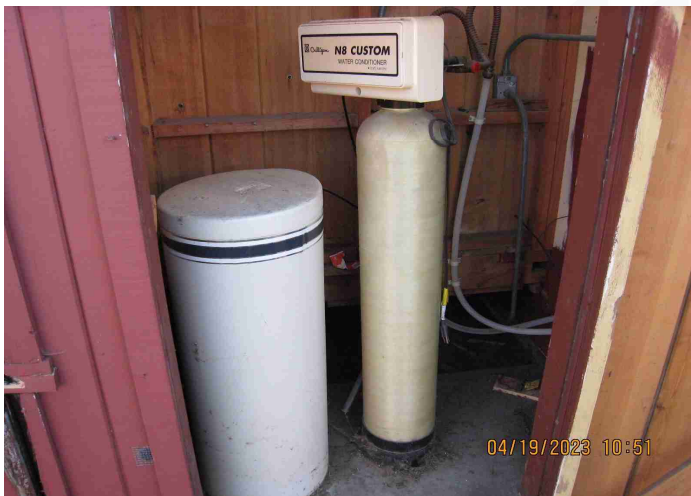
5.7 - A water softener was observed on the premises but was evaluated for leaks and cross connections only (evaluation of water softeners falls outside the scope of a home inspection). If the unit is to convey with the property, you may wish to have the system evaluated for defects and proper function by an appropriate specialist at this time. The system was disconnected and not functional at the time of the inspection.

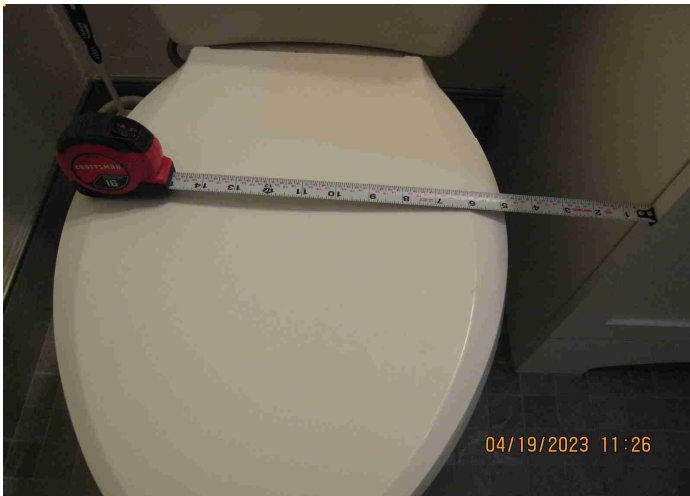
5.13 - The toilet in the easternmost bathroom has less than the required clearances (min. 15 inches to center) from the side cabinet and you should have this condition corrected for safety.

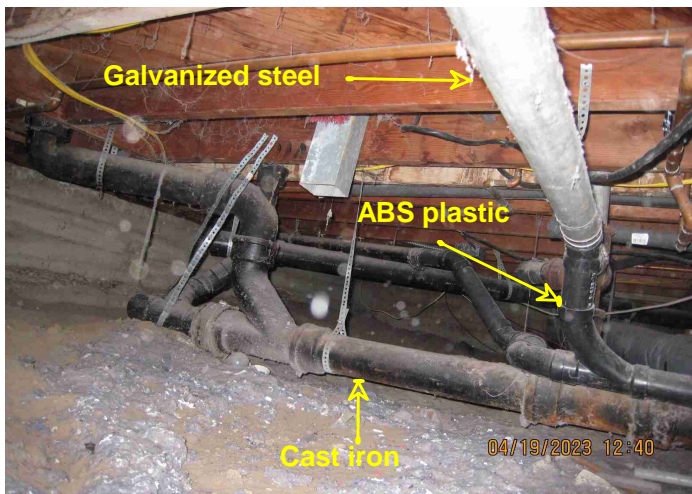
5.22 - The drainage and vent piping is predominately older/original cast iron and galvanized steel with a significant amount of newer ABS plastic.

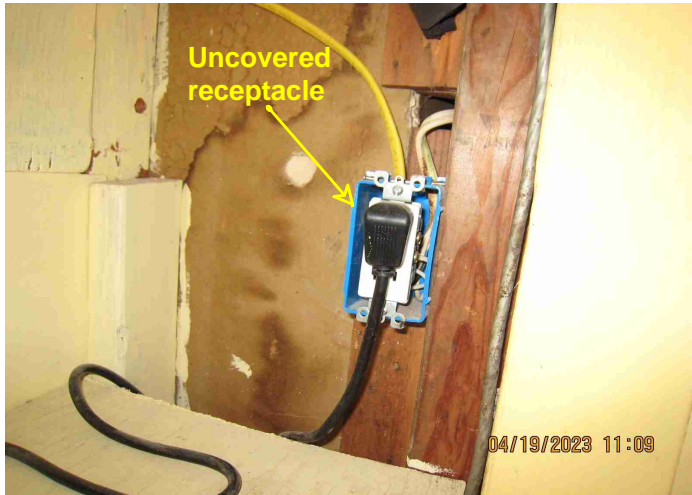
wiring, uncapped and exposed wiring, wiring that does not terminate inside a junction box, ungrounded receptacles, uncovered receptacles, etc. We recommend that an appropriately qualified and licensed electrician go room-to-room to investigate and repair any and all unsafe wiring conditions at this time.

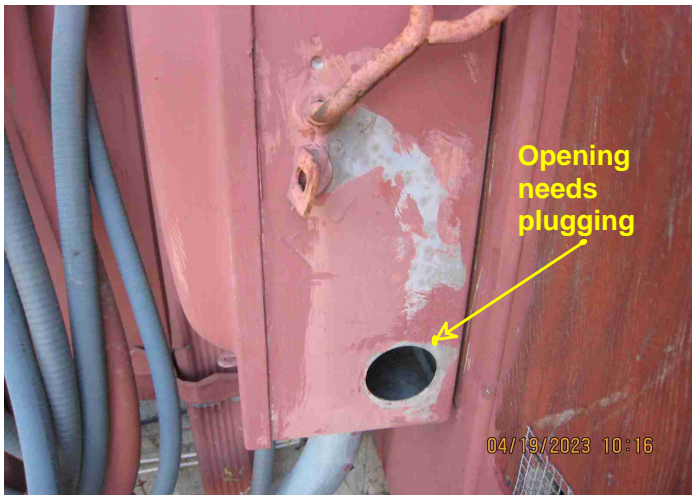
6.22 - There is an opening in the junction box adjacent to the service equipment panel that needs plugging to help prevent pest/moisture entry.

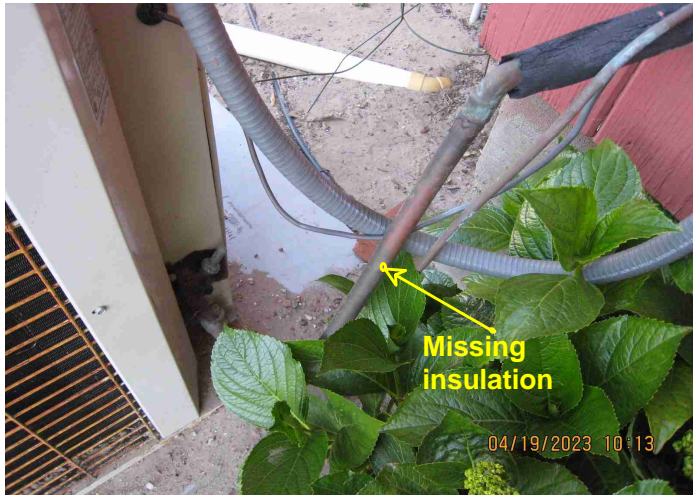
7.10 - Insulation is missing from the larger refrigerant line and we recommend that insulation be installed to help prevent condensation leakage and for increased efficiency/energy savings (easily remedied).

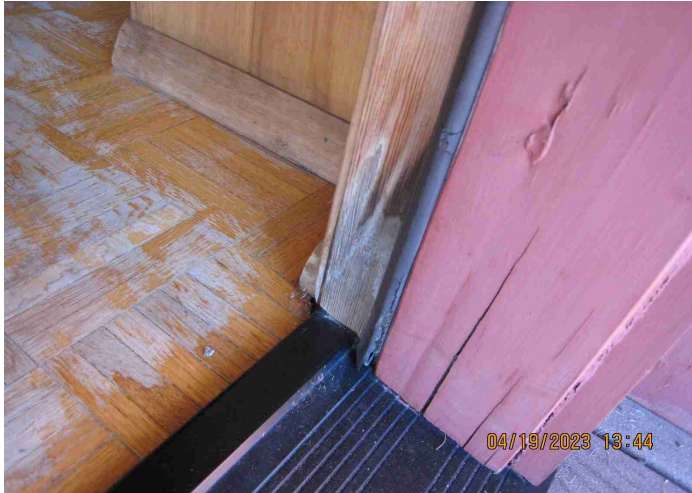
8.10 - There is evidence of water intrusion at the floor at the base of the main entry door. We recommend that the door be evaluated and made watertight by an appropriate specialist. A pest control inspection and report should note the presence of any wood damage or decay and the need, if any, for repair.

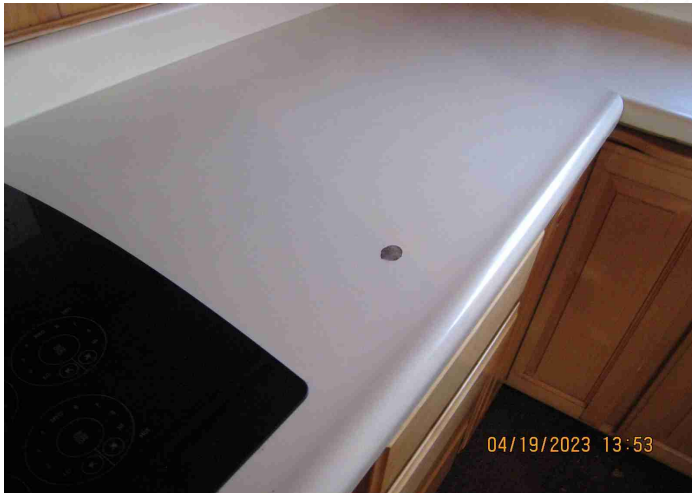
8.11 - The kitchen countertop has some cosmetic damage.

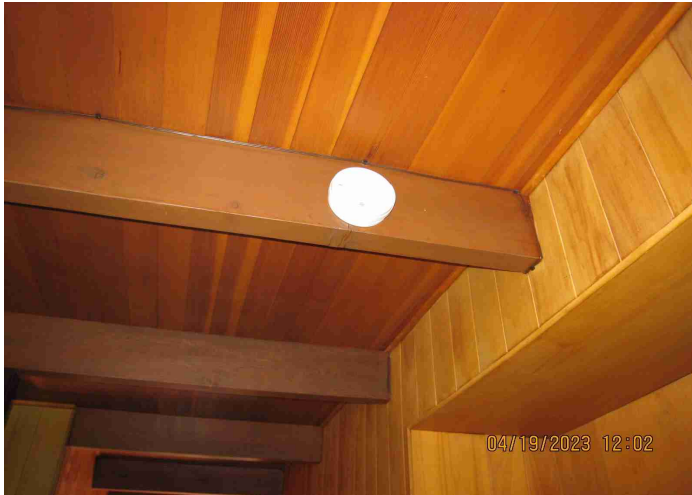
8.26 - Smoke alarms have a life expectancy of 10 years. After this time the sensors start to lose their sensitivity. There is an older and obsolete battery operated smoke alarm in the bedroom hallway that

should be considered unreliable and that we recommend be replaced.

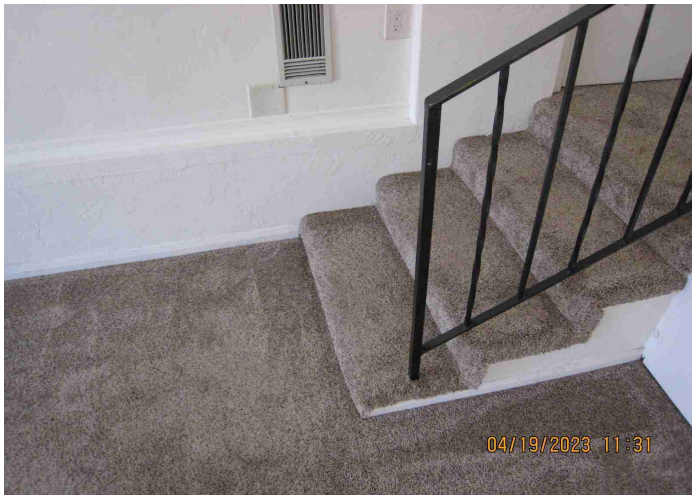
8.31 - The stair handrailing in the converted garage does not extend beyond the lower step as currently required for safety. Correction is recommended for safety.

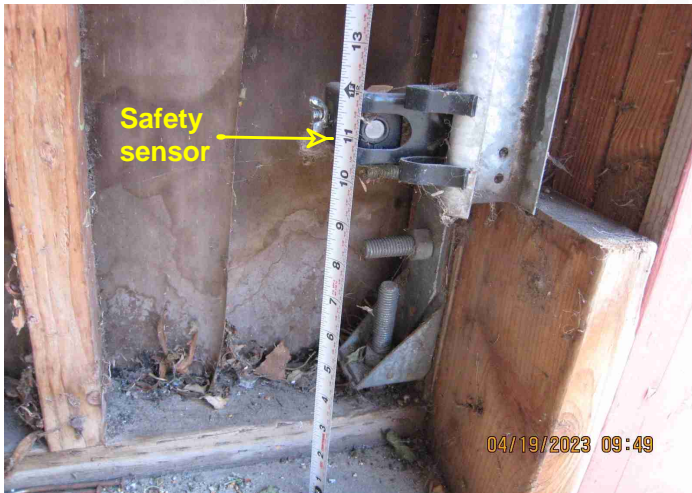
8.38 - The south electronic safety beam/sensor for the vehicle door is too high and should be no more than 6 inches above the garage floor. We recommend relocating/lowering these auto-reversing safety devices for safety.

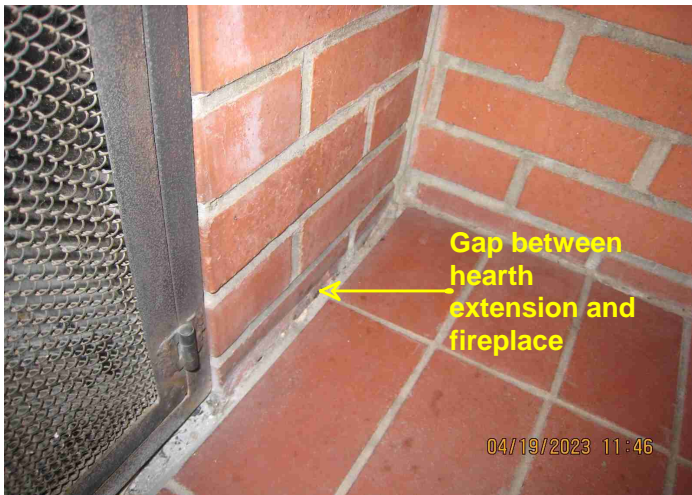
9.9 - The hearth extension has settled away from the fireplace and should be evaluated further by an appropriate specialist to determine if correction/repair is necessary at this time.

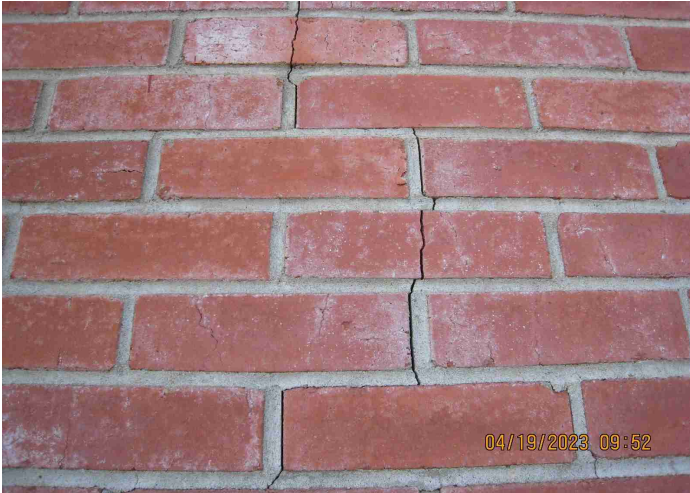
9.11 - The chimney appears to have shifted or settled as evidenced by step cracks in the mortar joints. Repairs are needed. We recommend that the chimney be evaluated by a qualified fireplace specialist for further remarks and recommendations at this time.

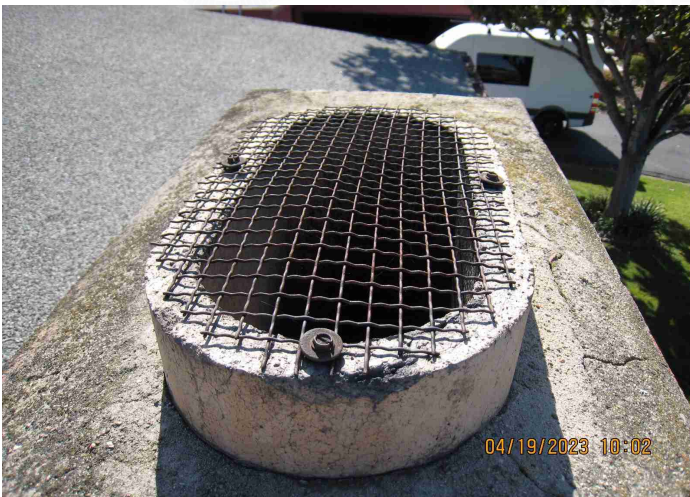
9.13 - The flat screen spark arrestor needs replacing with one that surrounds the flue opening. Installing a combination spark arrestor and weather cap assembly is recommended.
